NOTICE OF TREE REMOVAL PERMIT APPLICATION

Planning File No.: PLN2018-14

Description: Removal of One (1) Redwood Tree and One (1) Liquidambar Tree

AN ASSESSMENT OF THE LIQUIDAMBAR AND COAST REDWOOD TREE'S OF CONCERN
AT THE FAIRMEADOWS COMMUNITY - LATIMER CIRCLE, CAMPBELL - CALIFORNIA

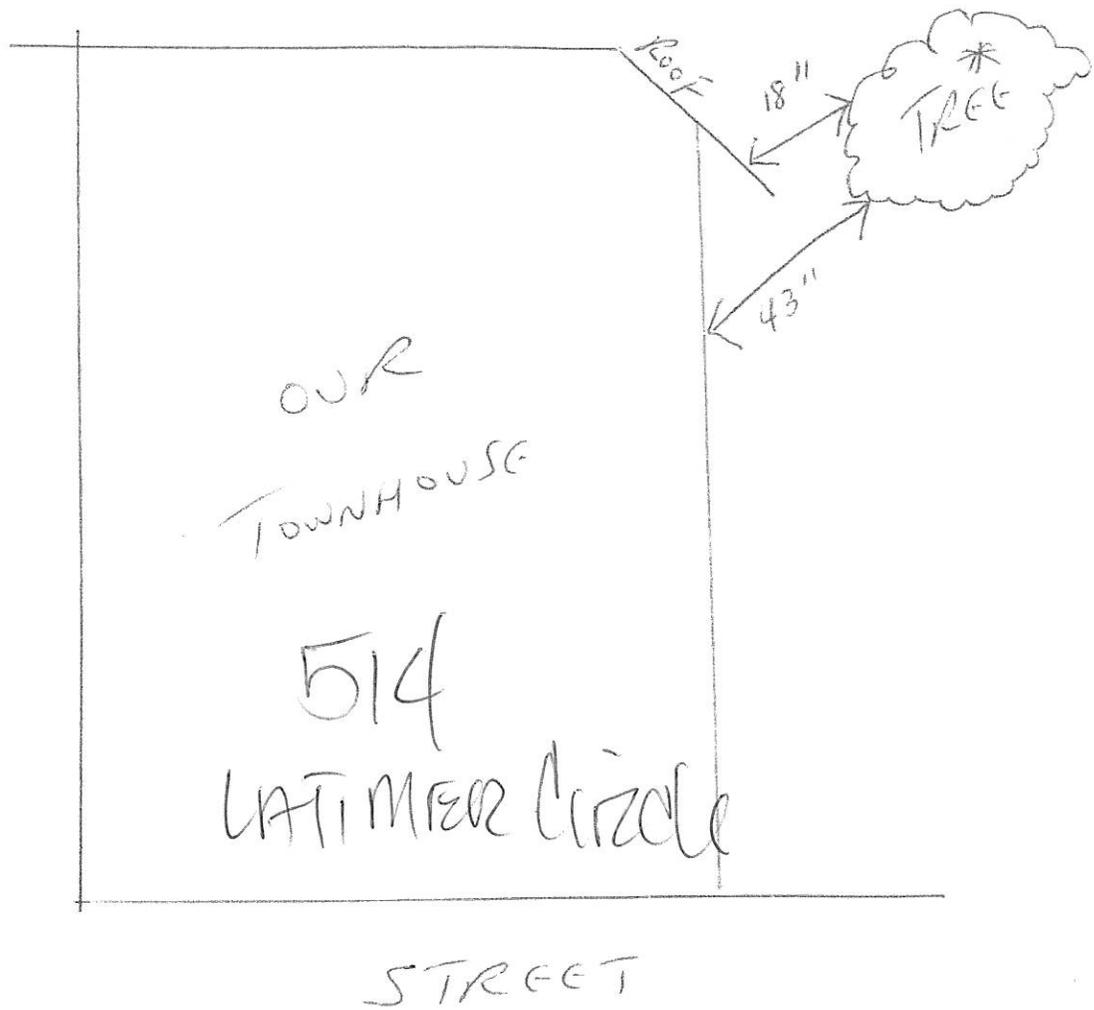
SITE PLAN

* TREE CIRCUMFERENCE IS 15 FEET
ASSUMED DIAMETER IS 4.8 FEET ($15 \div 3.14$)

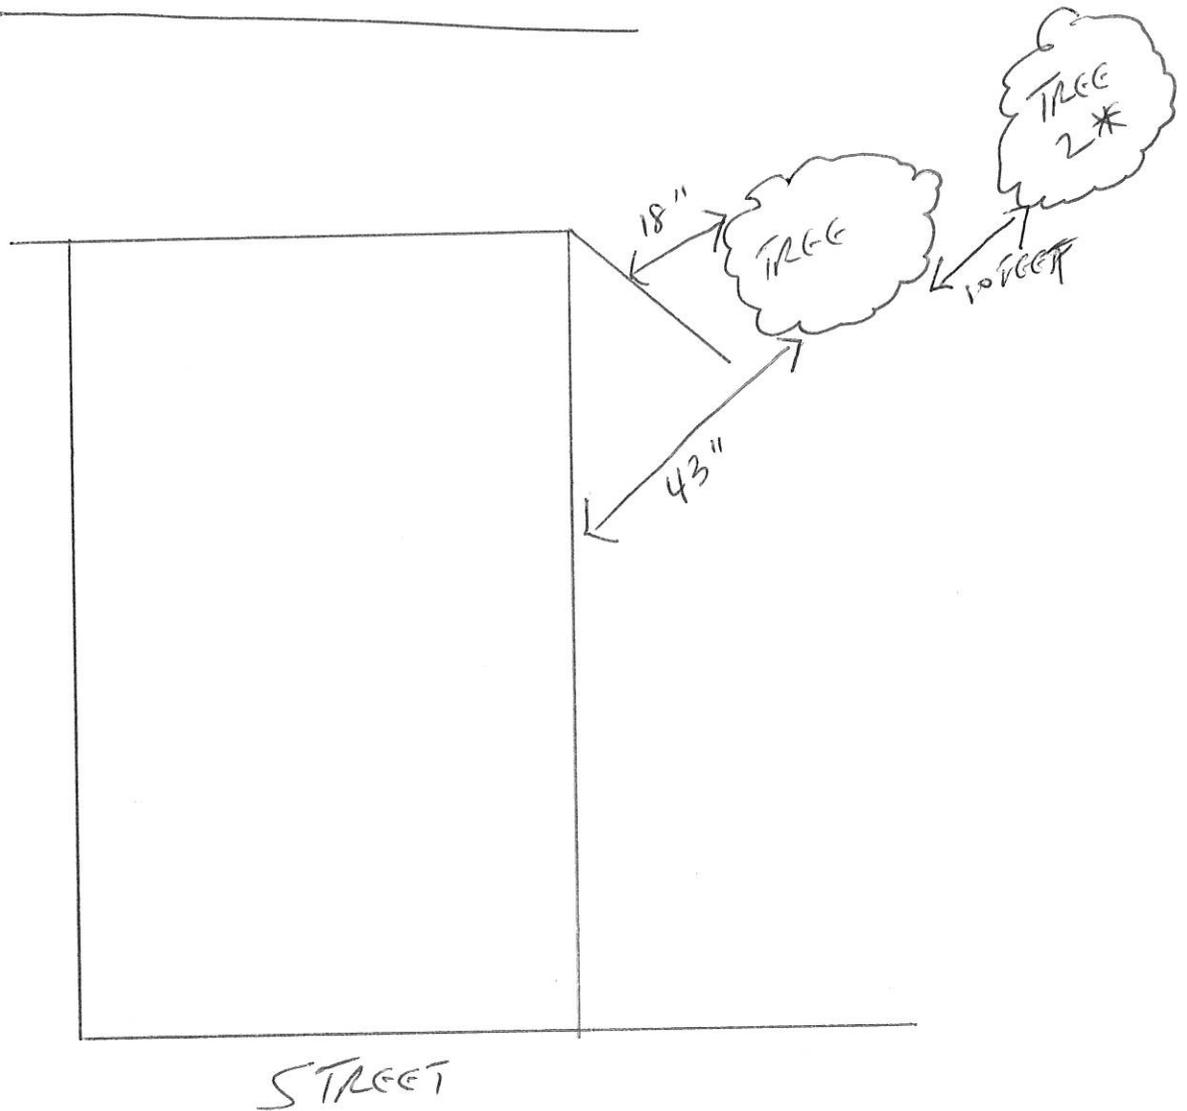
REPLACEMENT PLAN

* THERE IS AN EXISTING ^{SMALLER} REDWOOD TREE DIAMETRICALLY BEHIND THE TREE WHOSE REMOVAL IS APPLIED FOR.

THE DISTANCE BETWEEN THE 2 REDWOODS TRUNK TO TRUNK IS APPROXIMATELY 10 FEET

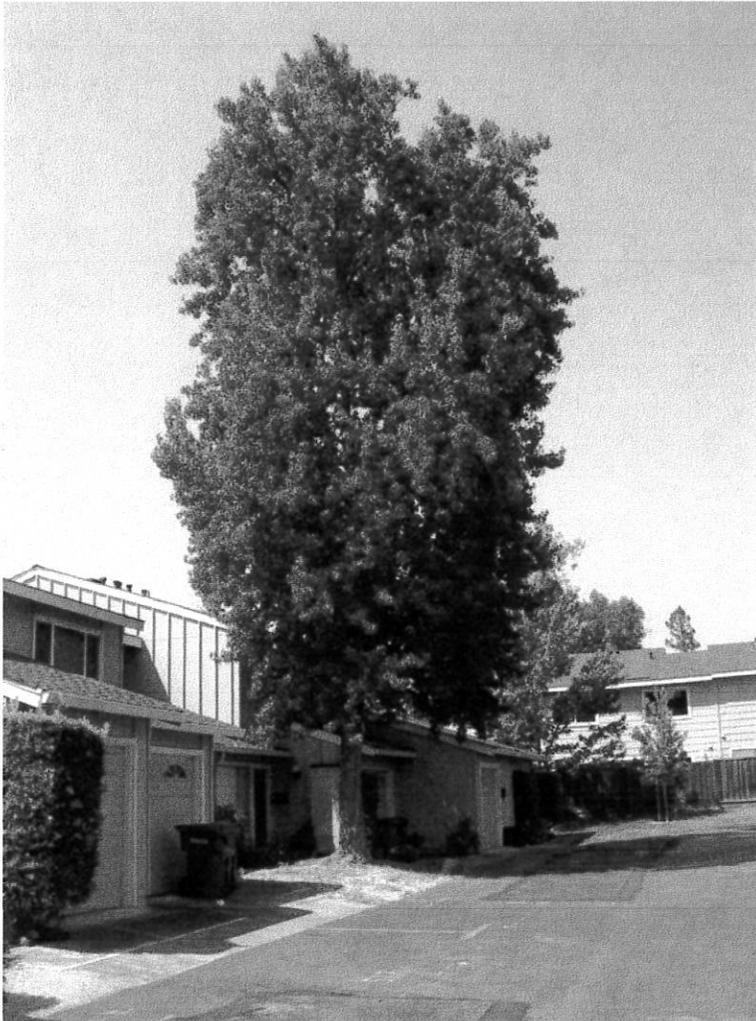
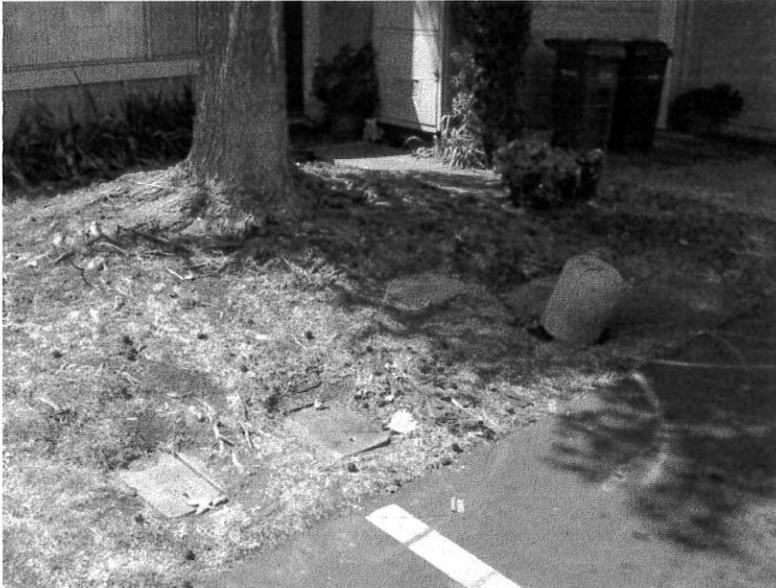
Tree #1 - 18-inch DBH Liquidambar Tree (*Liquidambar styraciflua*):

This tree is located within the landscaped area in the front of 513 Latimer Circle.

The tree is growing within very close proximity to five utility boxes and an adjacent asphalt parking area. The utility boxes service underground domestic water, irrigation, PG & E and communications services. A number of these boxes have been displaced and damaged by root growth and expansion. I also noted that the concrete pathway to the front door of the residence had been lifted by root growth. The pathway surface has been shaved in order to reduce potential tripping hazards. It is my understanding that there is also a sanitary sewer line that runs under the root structure of this tree.

The subject tree has an 18-inch trunk diameter when measured at 54-inches above grade (Standard DBH Measurement). I estimate that it is approximately 65-feet tall and that it has an average canopy spread of about 25-feet. This tree exhibits good health as evidenced by its foliage condition and it has a fair structural condition. I noted that this tree has developed a very surface rooted growth pattern. This surface root growth pattern resulted from inherent species characteristics, the influence of heavy soils and shallow turf irrigation and the restricted root zone area within which this tree is growing.

This tree is causing significant root damage to the adjacent utility boxes and the entrance pathway to the residence. The tree has the genetic potential to get larger in size and there is the potential for even greater damage to these services in the future. It is also my understanding that the sewer service line connecting to this residence is also situated within close proximity to the trunk. This service is vulnerable to root damage as well. It is possible that the tree's root growth may damage the foundation of the adjacent house in the future.

There are no practical means available to limit ongoing damage to these services in this context. Root pruning work and the utilization of root barriers will not provide an effective solution due to the location of this tree and the nature of its invasive root growth pattern. Tree removal and replacement is recommended. This action will serve to facilitate the repair and replacement of surrounding underground services and the adjacent entry pathway. It will also facilitate the renovation of the landscape in the front of the house.

I recommend that this tree is removed and replaced with a more appropriate species in order to prevent further damage to utilities and surrounding infrastructure. The stump and surrounding root mass must be ground out carefully and an underground service audit is required beforehand (grind the entire landscape area in front of 513 and 515 Latimer Circle). All of the residual grindings must be removed and replaced with new topsoil, to allow for landscape renovation and the successful establishment of a replacement tree within the same general area.

I recommend the planting of a 15-gallon (or larger) Chinese Pistache (*Pistacia chinensis*) as a replacement tree for this location. This species is noted as having a benign root growth pattern.

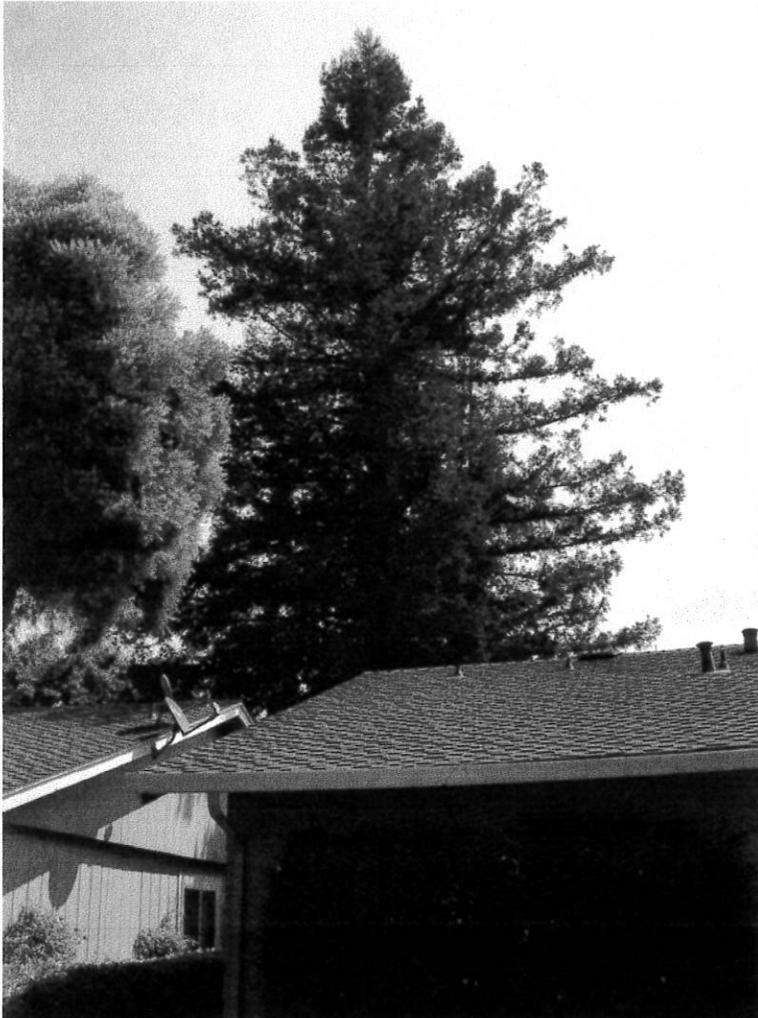
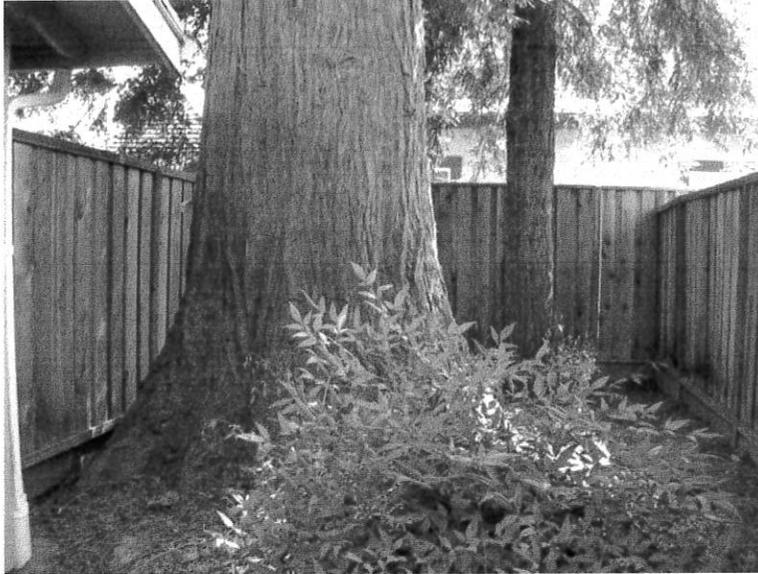
Tree #2 - 51-inch DBH Coast Redwood (*Sequoia sempervirens*):

The tree is located in the rear of the landscape area in between the residences at #514 and #516 Latimer Circle.

The trunk of the subject tree is located in between the back yards of these residences, in a twelve-foot wide area of landscape. The base of the trunk is setback 24-inches from the back corner of the foundation of the house at #514 Latimer Circle. I also noted that the trunk is situated within very close proximity to the overhanging eave at the back of this house.

The subject Redwood Tree has a 51-inch trunk diameter measured at 54-inches above grade. I estimate that it is approximately 120-feet tall and that it has a canopy spread of about 45-feet. The tree exhibited fair health as evidenced by its canopy condition (likely influenced by the recent period of prolonged drought conditions) and it has a poor structural condition, having been topped a number of years ago. I noted that the trunk was topped at approximately 80-feet above grade and that it has developed two co-dominant secondary trunks above that point. These secondary trunks (or leaders) are about 40-feet tall and they appear to be poorly attached to the main trunk when observed from the ground.

Examination of the surrounding root structure at soil grade revealed that a number of these exposed roots had been pruned. I noted that the large diameter buttress root structure next to corner of the foundation had been pruned. I also observed that a number of other large roots had been pruned next to the back fence of the community property.

This large Redwood Tree has the genetic potential to get significantly larger over time and its root structure will likely cause further damage to the foundation of the closest residence in the future. The trunk of this tree will continue to expand and will come into contact with the eave of this house within the next five or more years.

This tree is structurally unsound due to the weak area of attachment between the co-dominant leaders and the main trunk. In the event that these leaders fail, they have the potential to strike the two closest residences and other residences on the adjacent property within their falling radius. This tree represents a potential hazard to surrounding life and property at this time. I considered the options of re-topping this tree or the installation of a support cable between the two leaders. I do not recommend topping work as this will promote an undesirable growth response and require ongoing maintenance in order to avoid future hazards from developing over time. This tree does not lend itself to support cable installation work due to the close proximity of the two co-dominant leaders. Even in the event that there is enough space, I would advise against this option when taking into account the growth rate of this tree, its exposure to high winds and the proximity of potential targets within its failure radius.

I recommend that this tree is removed in order to prevent further damage to the foundation of the adjacent residence and to abate a significant potential hazard to life and property within its proximity. The stump is best ground out and the residual grindings should be replaced with good quality topsoil. Another less desirable option could entail the cutting of the stump to grade and covering it with black plastic sheeting in order to exclude light and prevent regeneration.

I recommend that the adjacent 18-inch DBH Coast Redwood be preserved and that an appropriate 15-gallon (or larger) replacement tree is planted within the same area (or possibly in another location on the community property).
