NOTICE OF TREE REMOVAL PERMIT APPLICATION

Notice is hereby given that the Community Development Department of the City of Campbell has received an application for a Tree Removal Permit (PLN-2021-163) at 189 Redding Rd for the removal of one (1) Redwood tree measuring 36 inches in diameter located in the rear yard due to damage to the home. If approved, removal of the tree is subject to the replanting requirement of the Campbell Municipal Code.

Site Photographs

Re: Written Statement- Redwood- 189 Redding Road

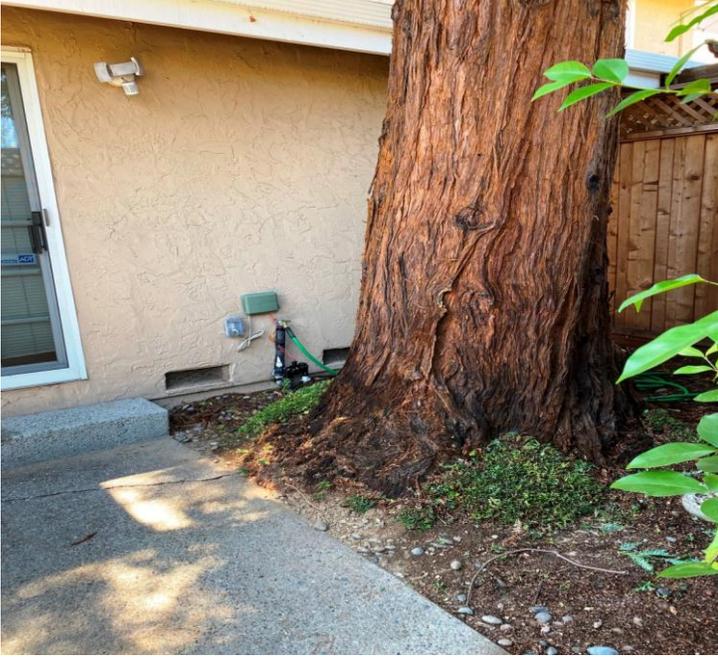
Location: 189 Redding Road

Description: Redwood- pushing against house foundation

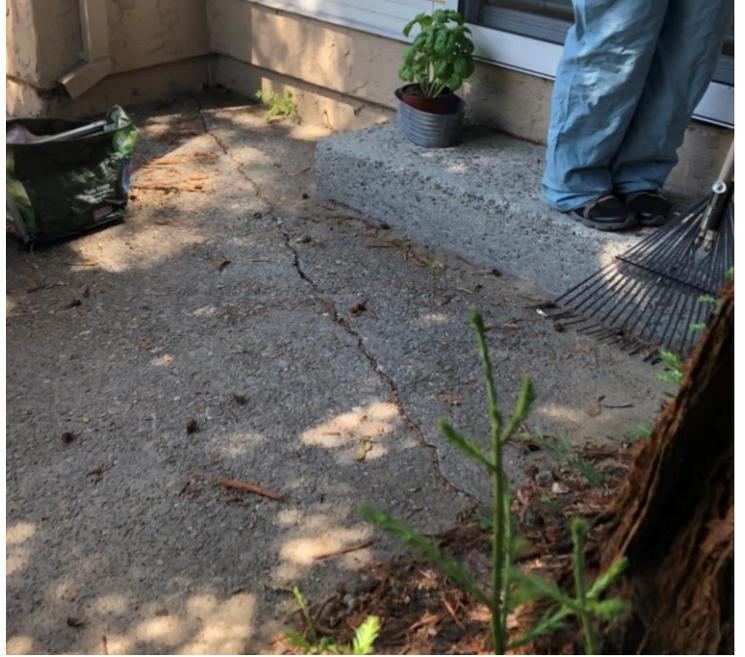
Location: 189 Redding Road

Description: Redwood- pushing against house foundation

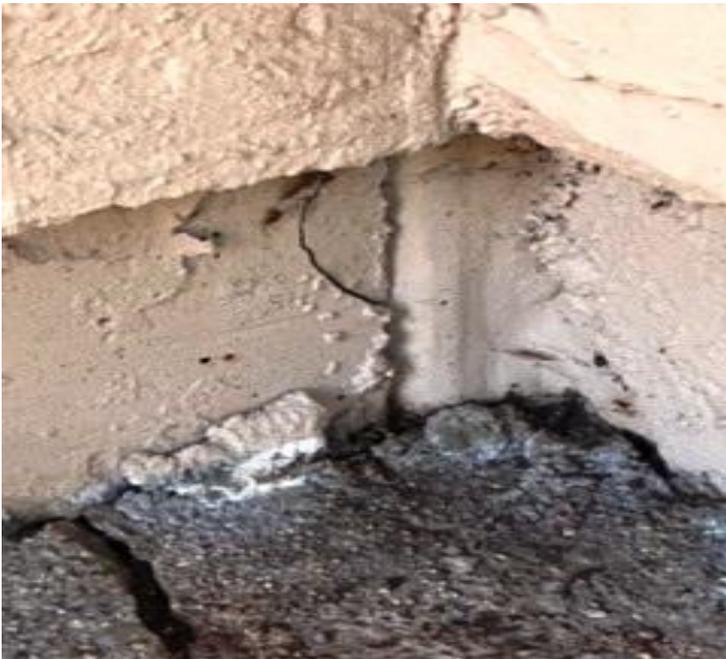
Location: 189 Redding Road

Description: Redwood- encroachment resulting in stemwall cracks

On the backyard side of the foundation, adjacent to the subject redwood tree, the inspection revealed one related stem wall foundation crack. The redwood pushing against the home's foundation is the cause of this stem wall distress. I am of the opinion that further foundation damage is inevitable as the tree continues to grow.

Based upon the evaluation detailed above, the redwood is located too close to the existing home foundation and structure. The redwood will assuredly grow in size and, as a result, will cause increasing damage to the house foundation. In addition, the redwood's close proximity to the home has significantly restricted the tree's available rooting space and increased the likelihood of failure. There are no mitigation efforts to address this deficiency. The redwood represents a safety hazard to the people /residents, as well as the adjacent homes. I recommend removal of the redwood and replacement with a species better-suited for the location.

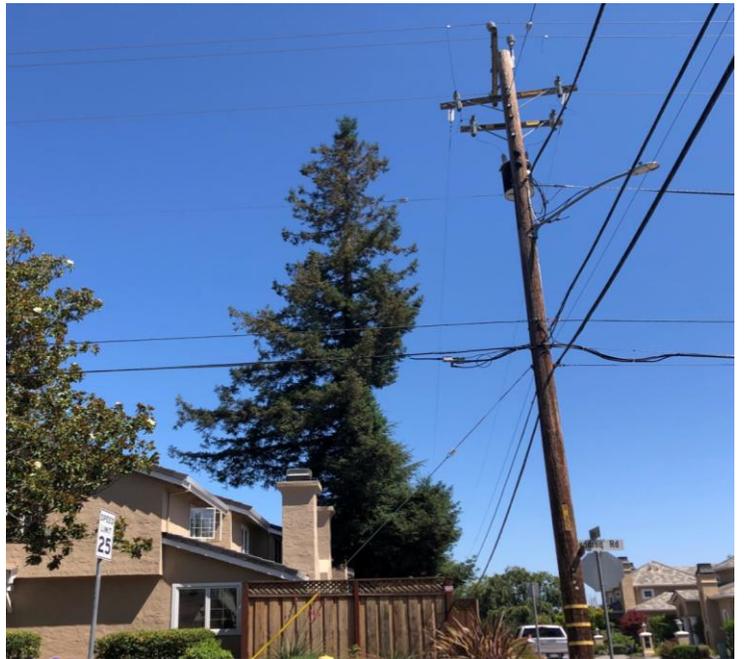
Location: 189 Redding Road

Description: Redwood- root system causing hardscape damage
