**CITY OF CAMPBELL**  
Community Development Department

**NOTICE OF TENTATIVE PARCEL MAP APPLICATION  
AND TREE REMOVAL PERMIT APPLICATION**

**File No.:** PLN2017-178 and PLN2017-311  
**Applicant:** H.C. Farahani  
**Project Address:** 251 Curtner Avenue  
**Property Owner:** H. C. Farahani  
**Zoning District:** R-1-8 Single-Family Residential (Campbell Village Neighborhood Plan)  
**General Plan:** Low Density Residential (Less than 4.5 units/gross acre)  
**Project Description:** Tentative Parcel Map (PLN2017-311) for a minor lot split to divide one existing parcel into two parcels and Tree Removal Permit (PLN2017-311) to remove one 14-inch diameter Oak Tree located near the southeast corner of the property due to utility interference and overplanting and one 32-inch diameter Oak Tree located near the southwest corner of the property due to utility interference. If approved, removal of the tree is subject to the replanting requirement of the Campbell Municipal Code.

**VESTING TENTATIVE MAP**  
**251 CURTNER AVE**  
 SANTA CLARA COUNTY  
 CITY OF CAMPBELL  
 CALIFORNIA

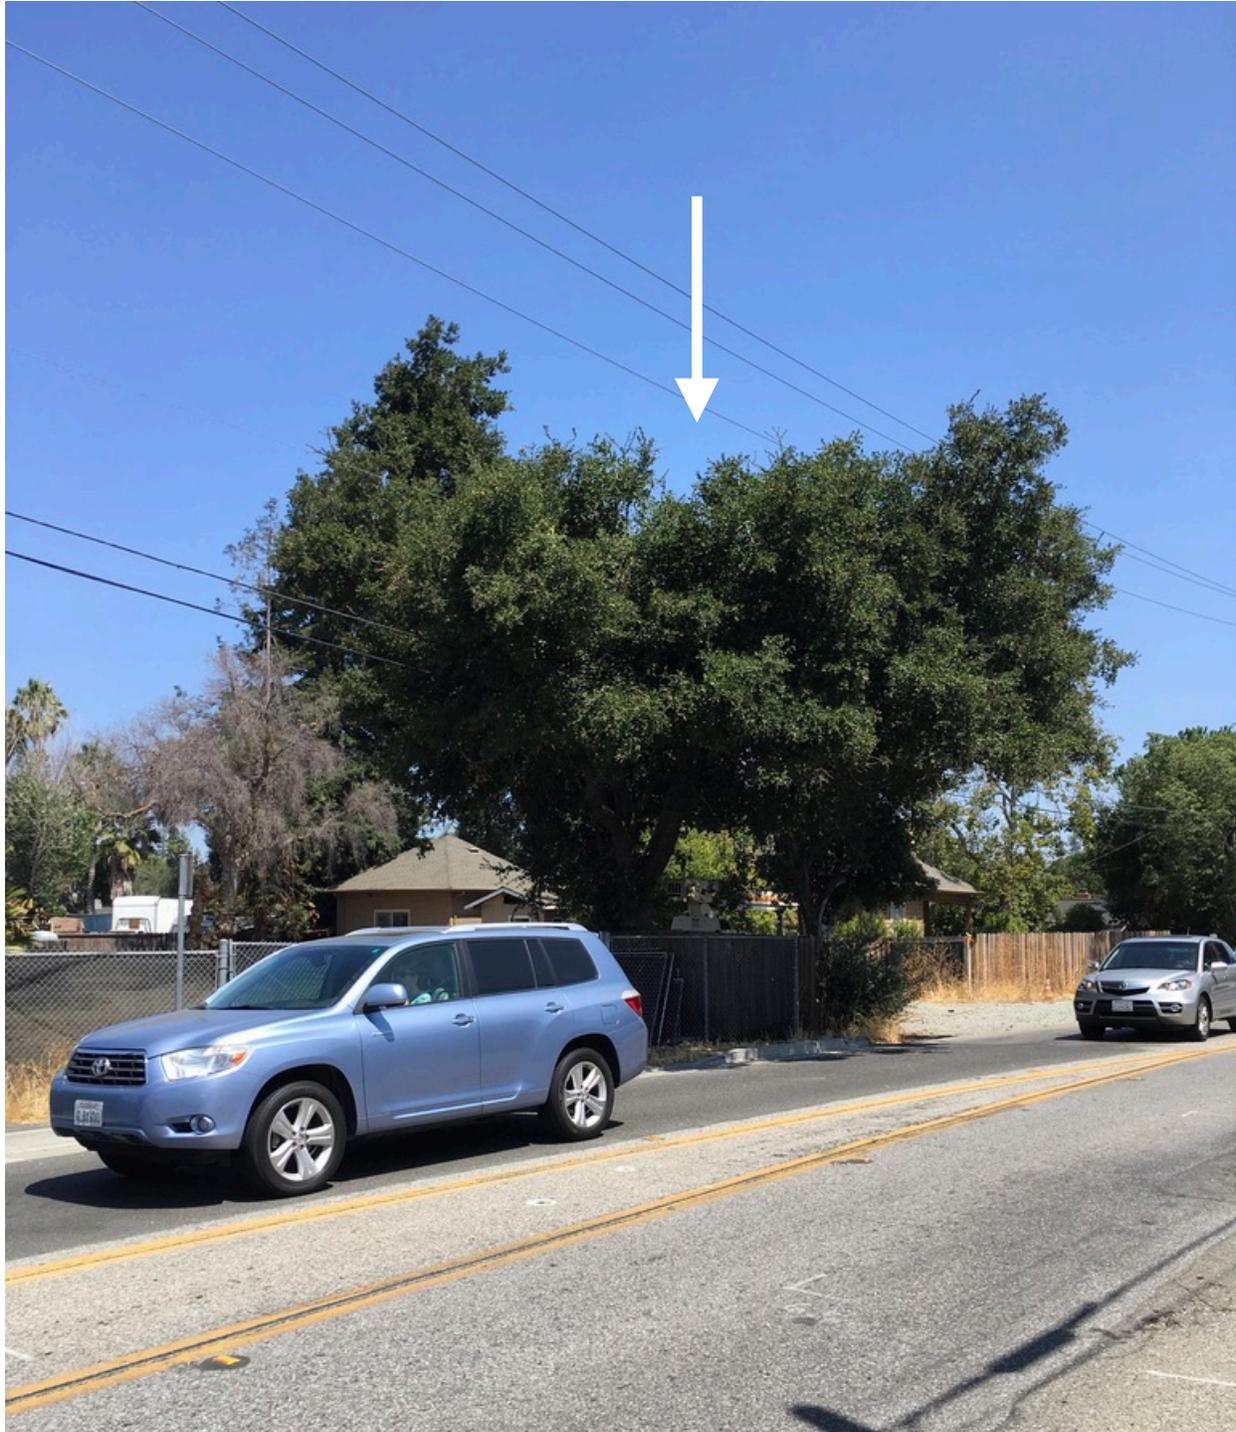
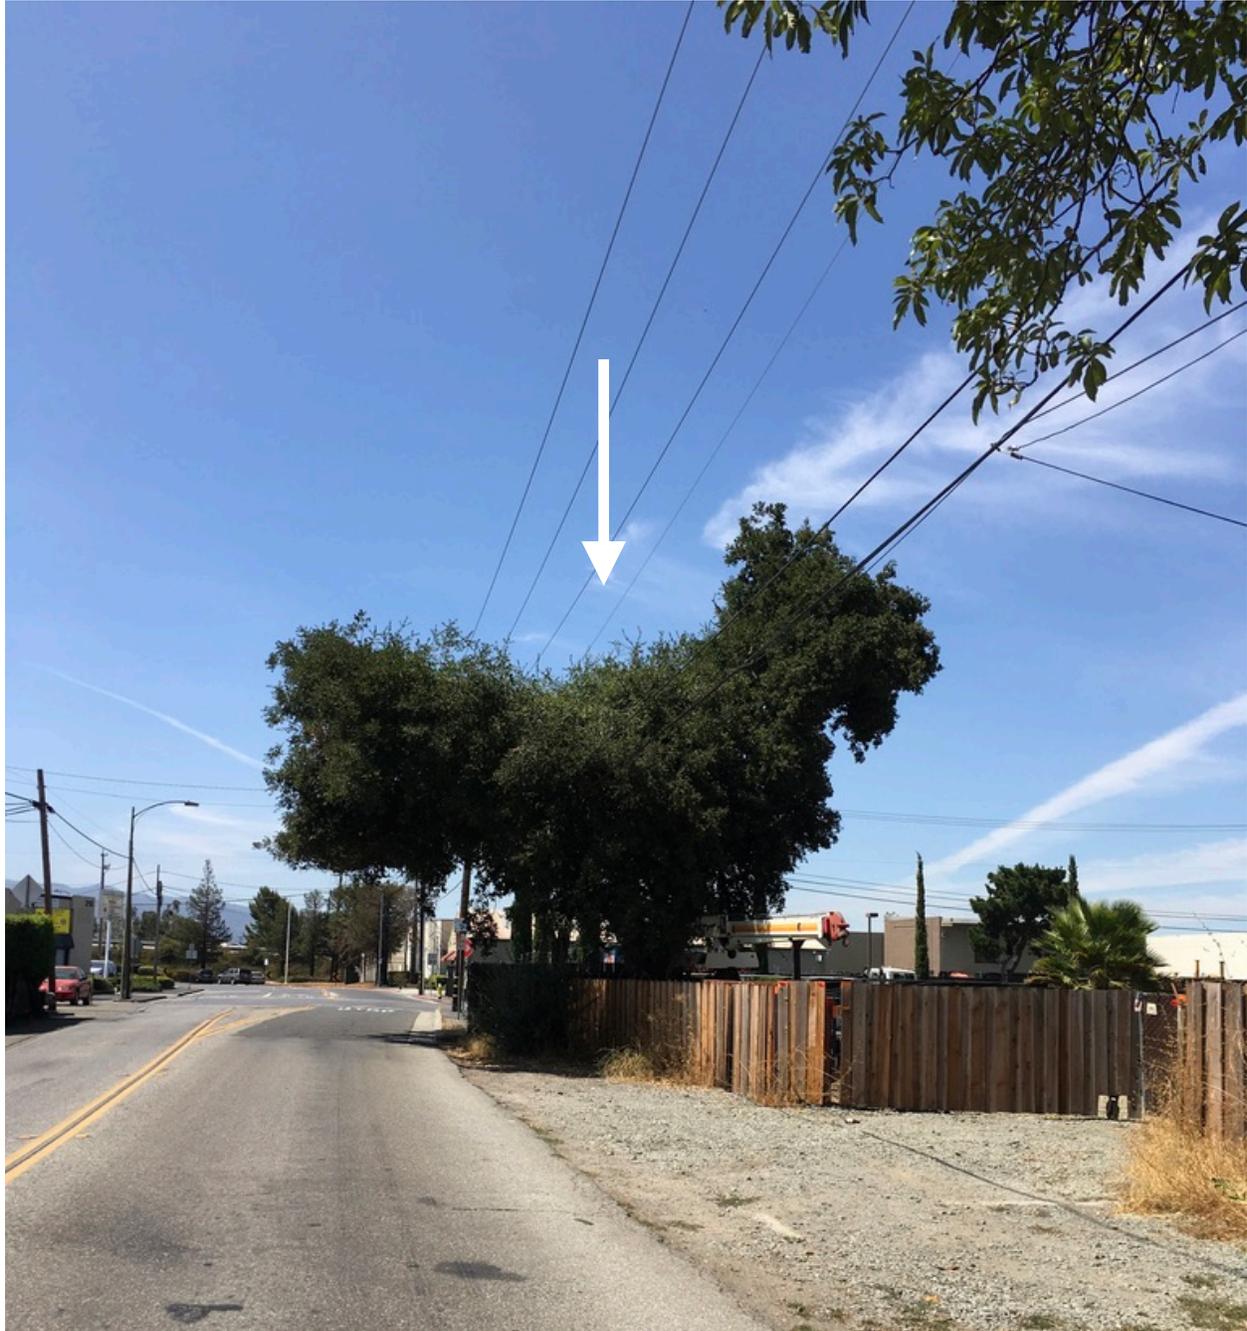
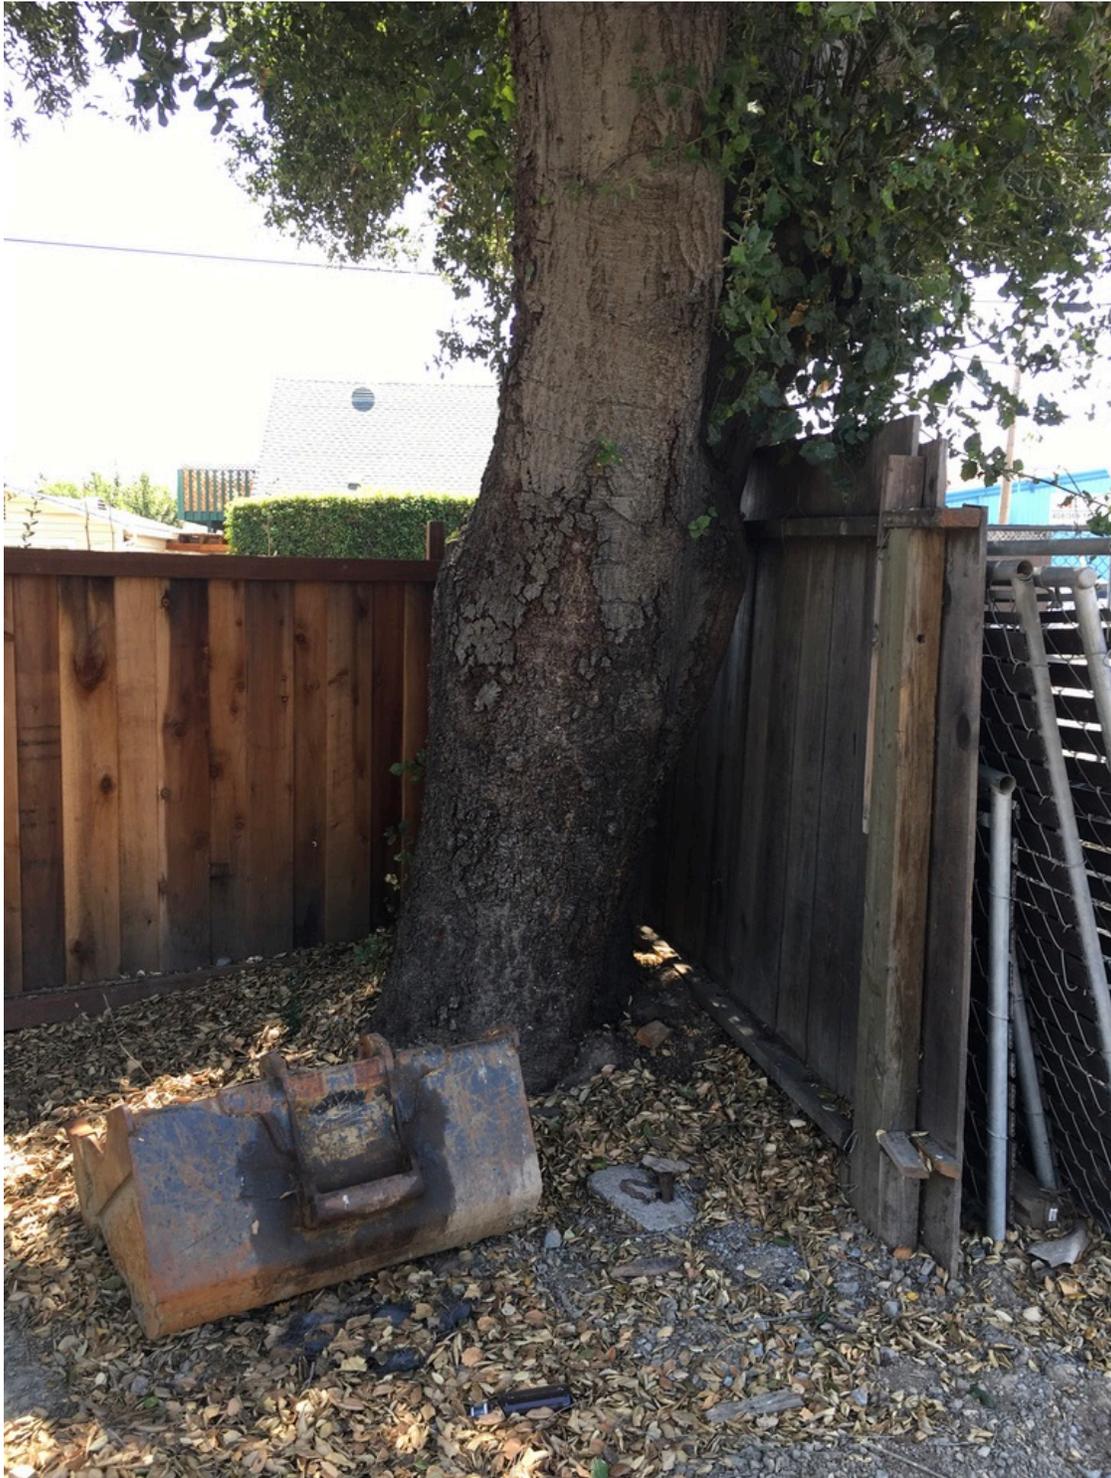
Both trees are in fair condition. Number one has a disfigured crown due to repeated reduction to accommodate the overhead utility while number two has a suppressed and asymmetric canopy growing under the adjacent pine. Number two also has multiple stems originating low on the trunk with acute angle attachments. Both trees have poor overall structure while their health is normal and vigorous. Trees in fair condition typically have minor problems or at least one structural defect or health concern. In many instances these problems can be mitigated through cultural practices such as pruning or a plant health care program.

Both trees have fair to poor suitability for conservation. Coast live oak number one is located directly under the high voltage utility lines and requires repeated reduction pruning. This type of pruning is aesthetically unpleasing and is a burden to the utility. Tree number two is suppressed under the adjacent pine and has an asymmetric crown with multiple stems. This tree's structure will forever be altered as it competes with the neighboring pine, unless the pine is to be removed. Trees with fair to poor suitability for conservation are expected to decline during or after construction regardless of management or the species or individual may possess characteristics that are incompatible or undesirable for the intended use of the site. Although these are a desirable species their locations and structural characteristics are poor.

### B1: Coast live oak number one with "V" cut utility clearance

Consider removing both coast live oaks and replacing them with new trees along the frontage or in the proposed park-strip for long term contributions to the community. Trees that are utility friendly and will not grow tall enough to be a problem with the overhead conductors along with those providing functional screening and storm water management should be selected.

Retain tree number one and remove tree number two. Retain tree number one and install the new sidewalk and driveway around the tree minimizing root damage and removal.

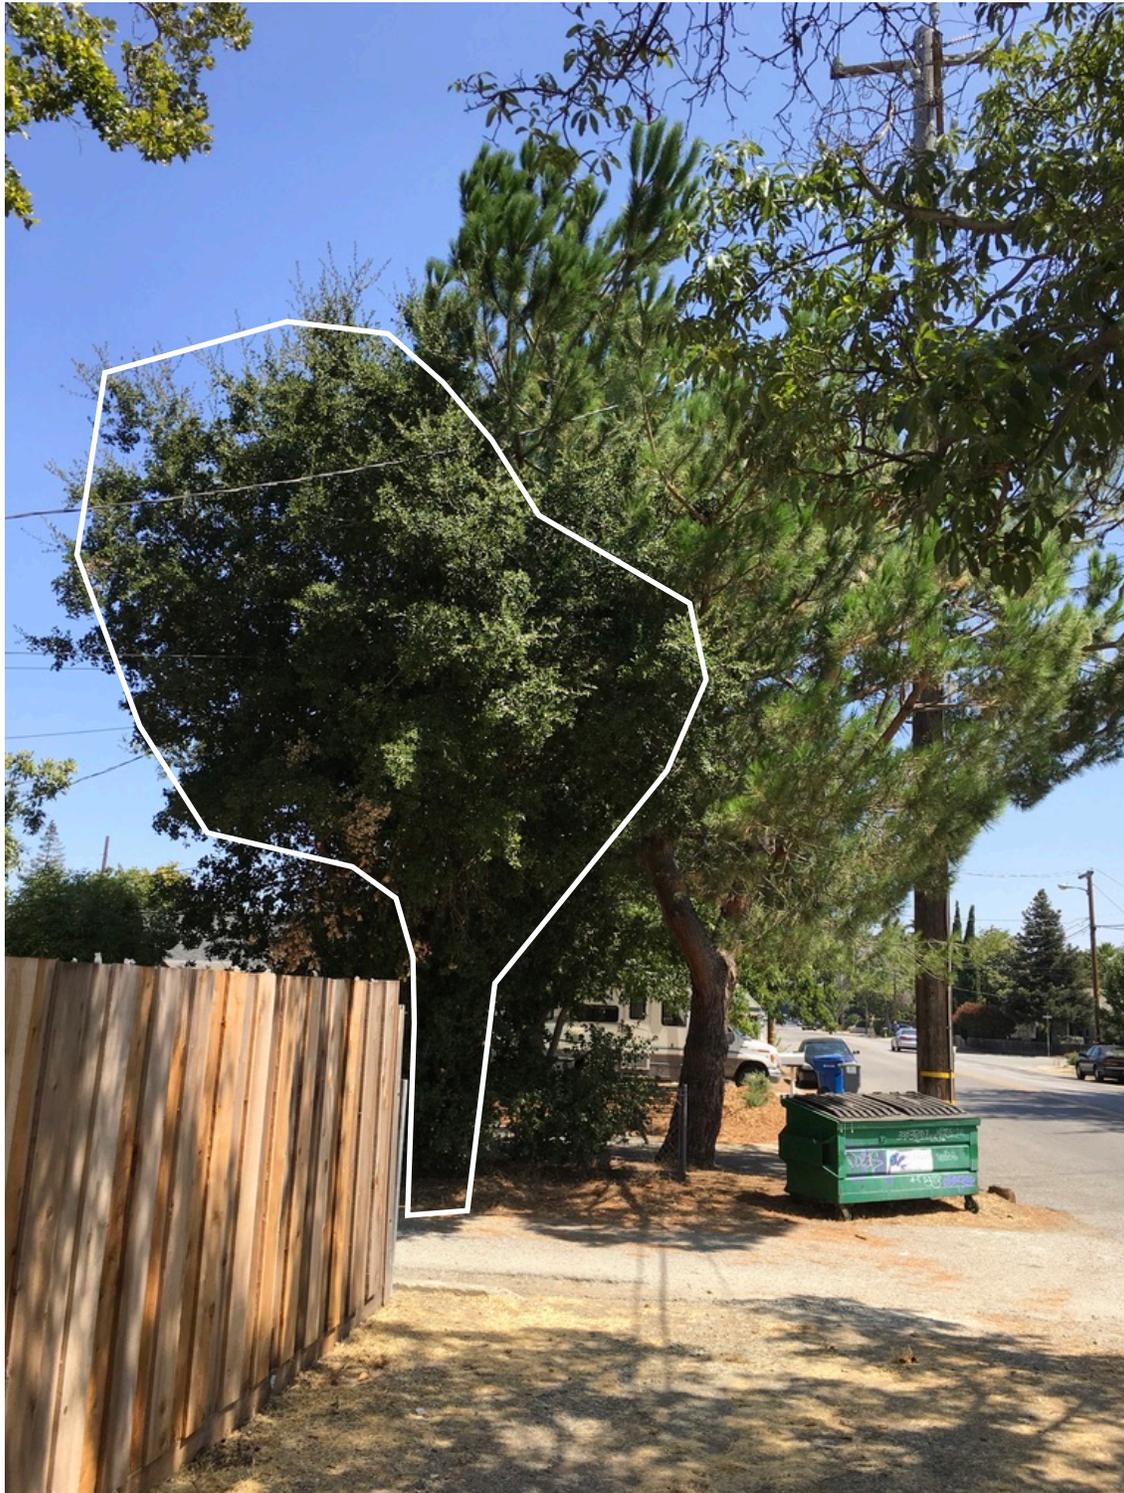
**C2: Coast live oak number two with suppressed asymmetric crown**

The proposed storm drain near tree number two would need to be rerouted or directionally bored to a depth of at least four feet under tree number two.

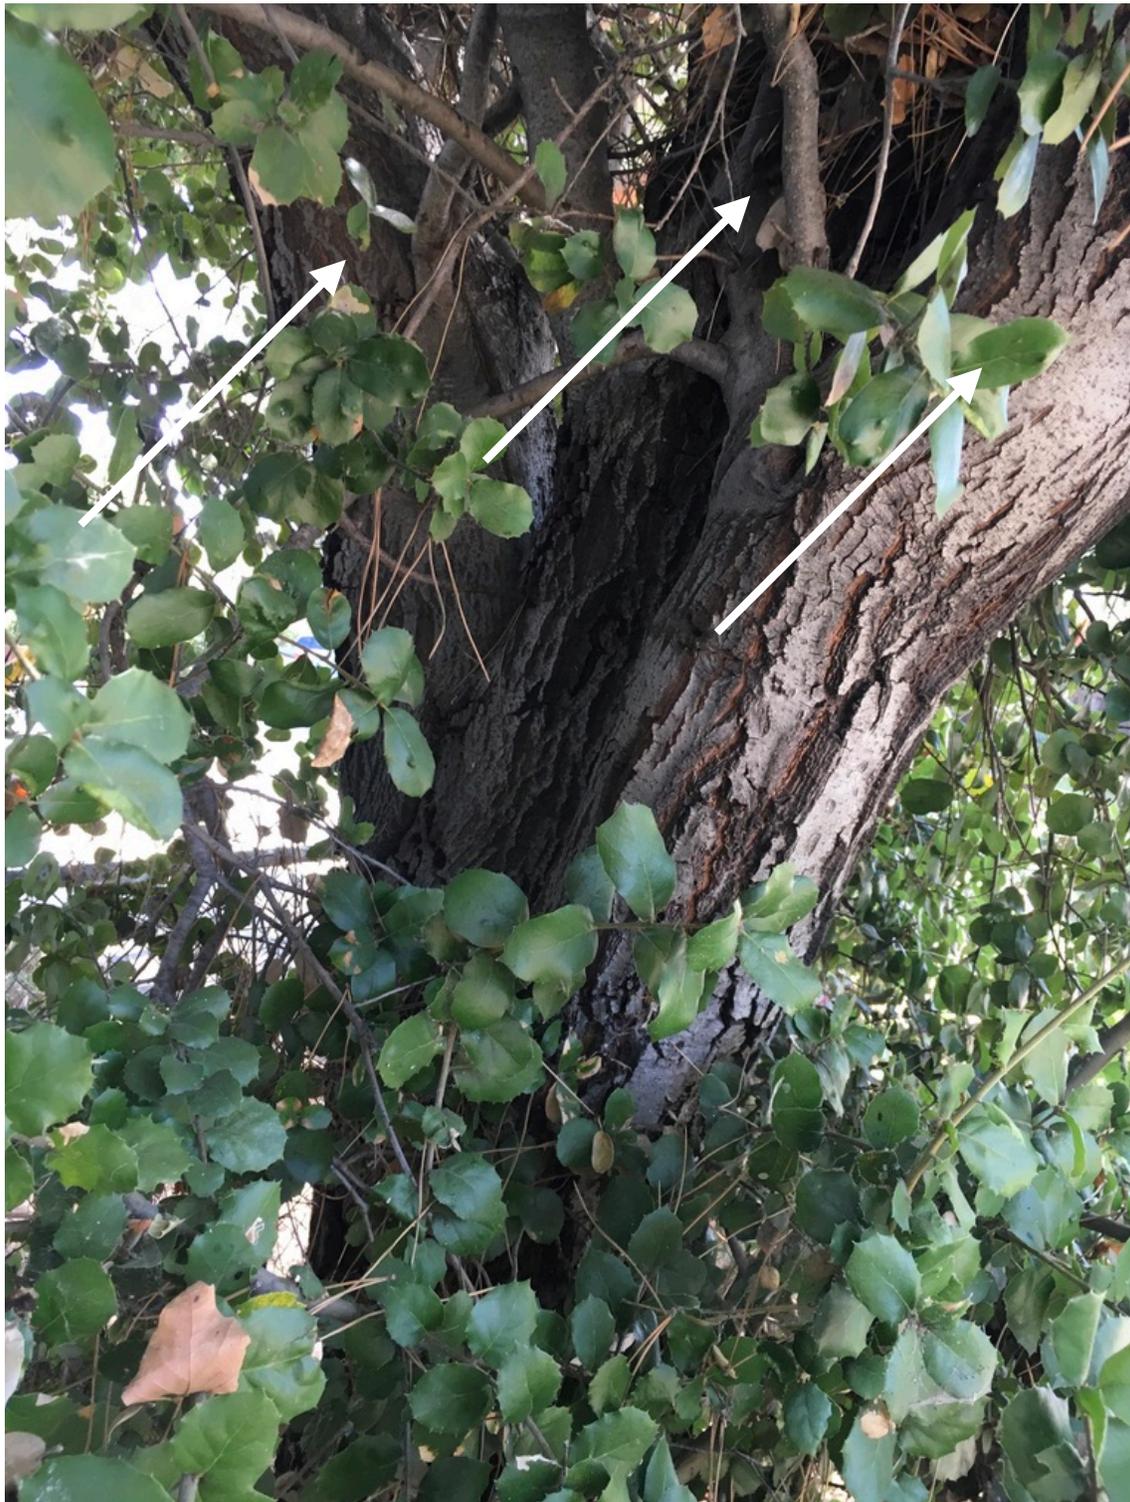
Multiple stems
