NOTICE OF TREE REMOVAL PERMIT APPLICATION

Project Location: 175 Curtner Ave
Application Type: Tree Removal Permit
Planning File No.: PLN2018-89
Description: Removal of Three (3) Redwood Trees

Arborist Letter

Public Storage, 175 S. Curtner Ave Campbell CA 95008

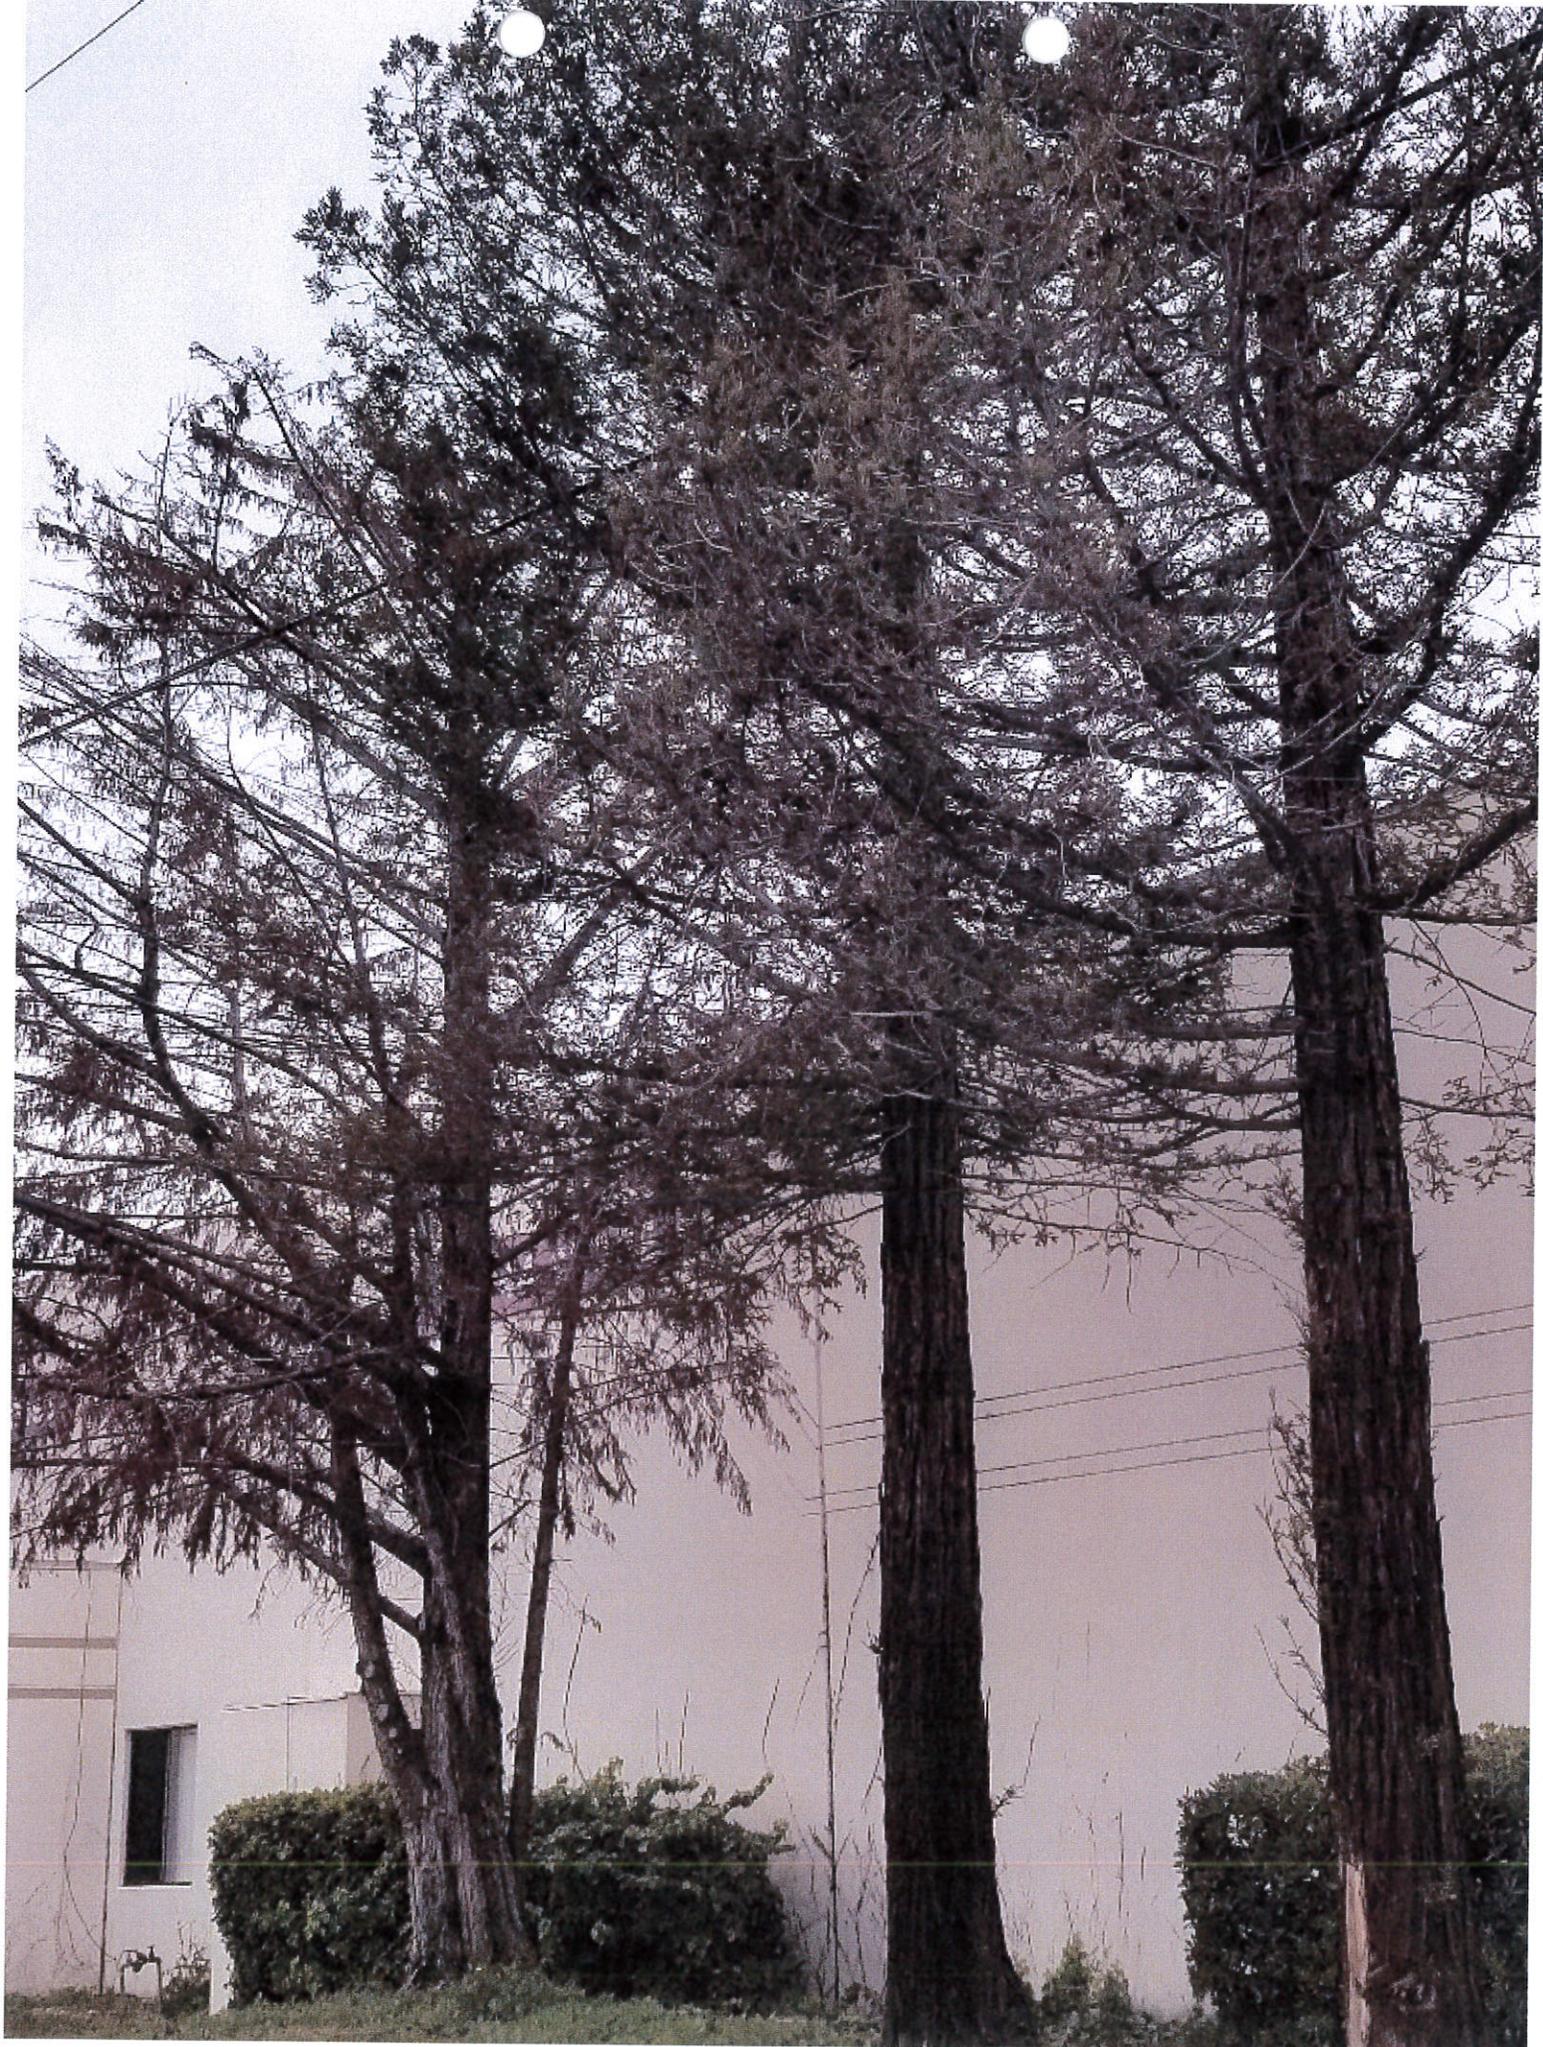
Previously topped by RGE
in poor health

Due to the potential for structural damage and current utility interference removal and replacement is recommended. A replacement plan with five 24 in box size trees with a species that appropriately matches the existing theme of the landscape is recommended. A smaller size tree at this site would be a more suitable and safer choice.

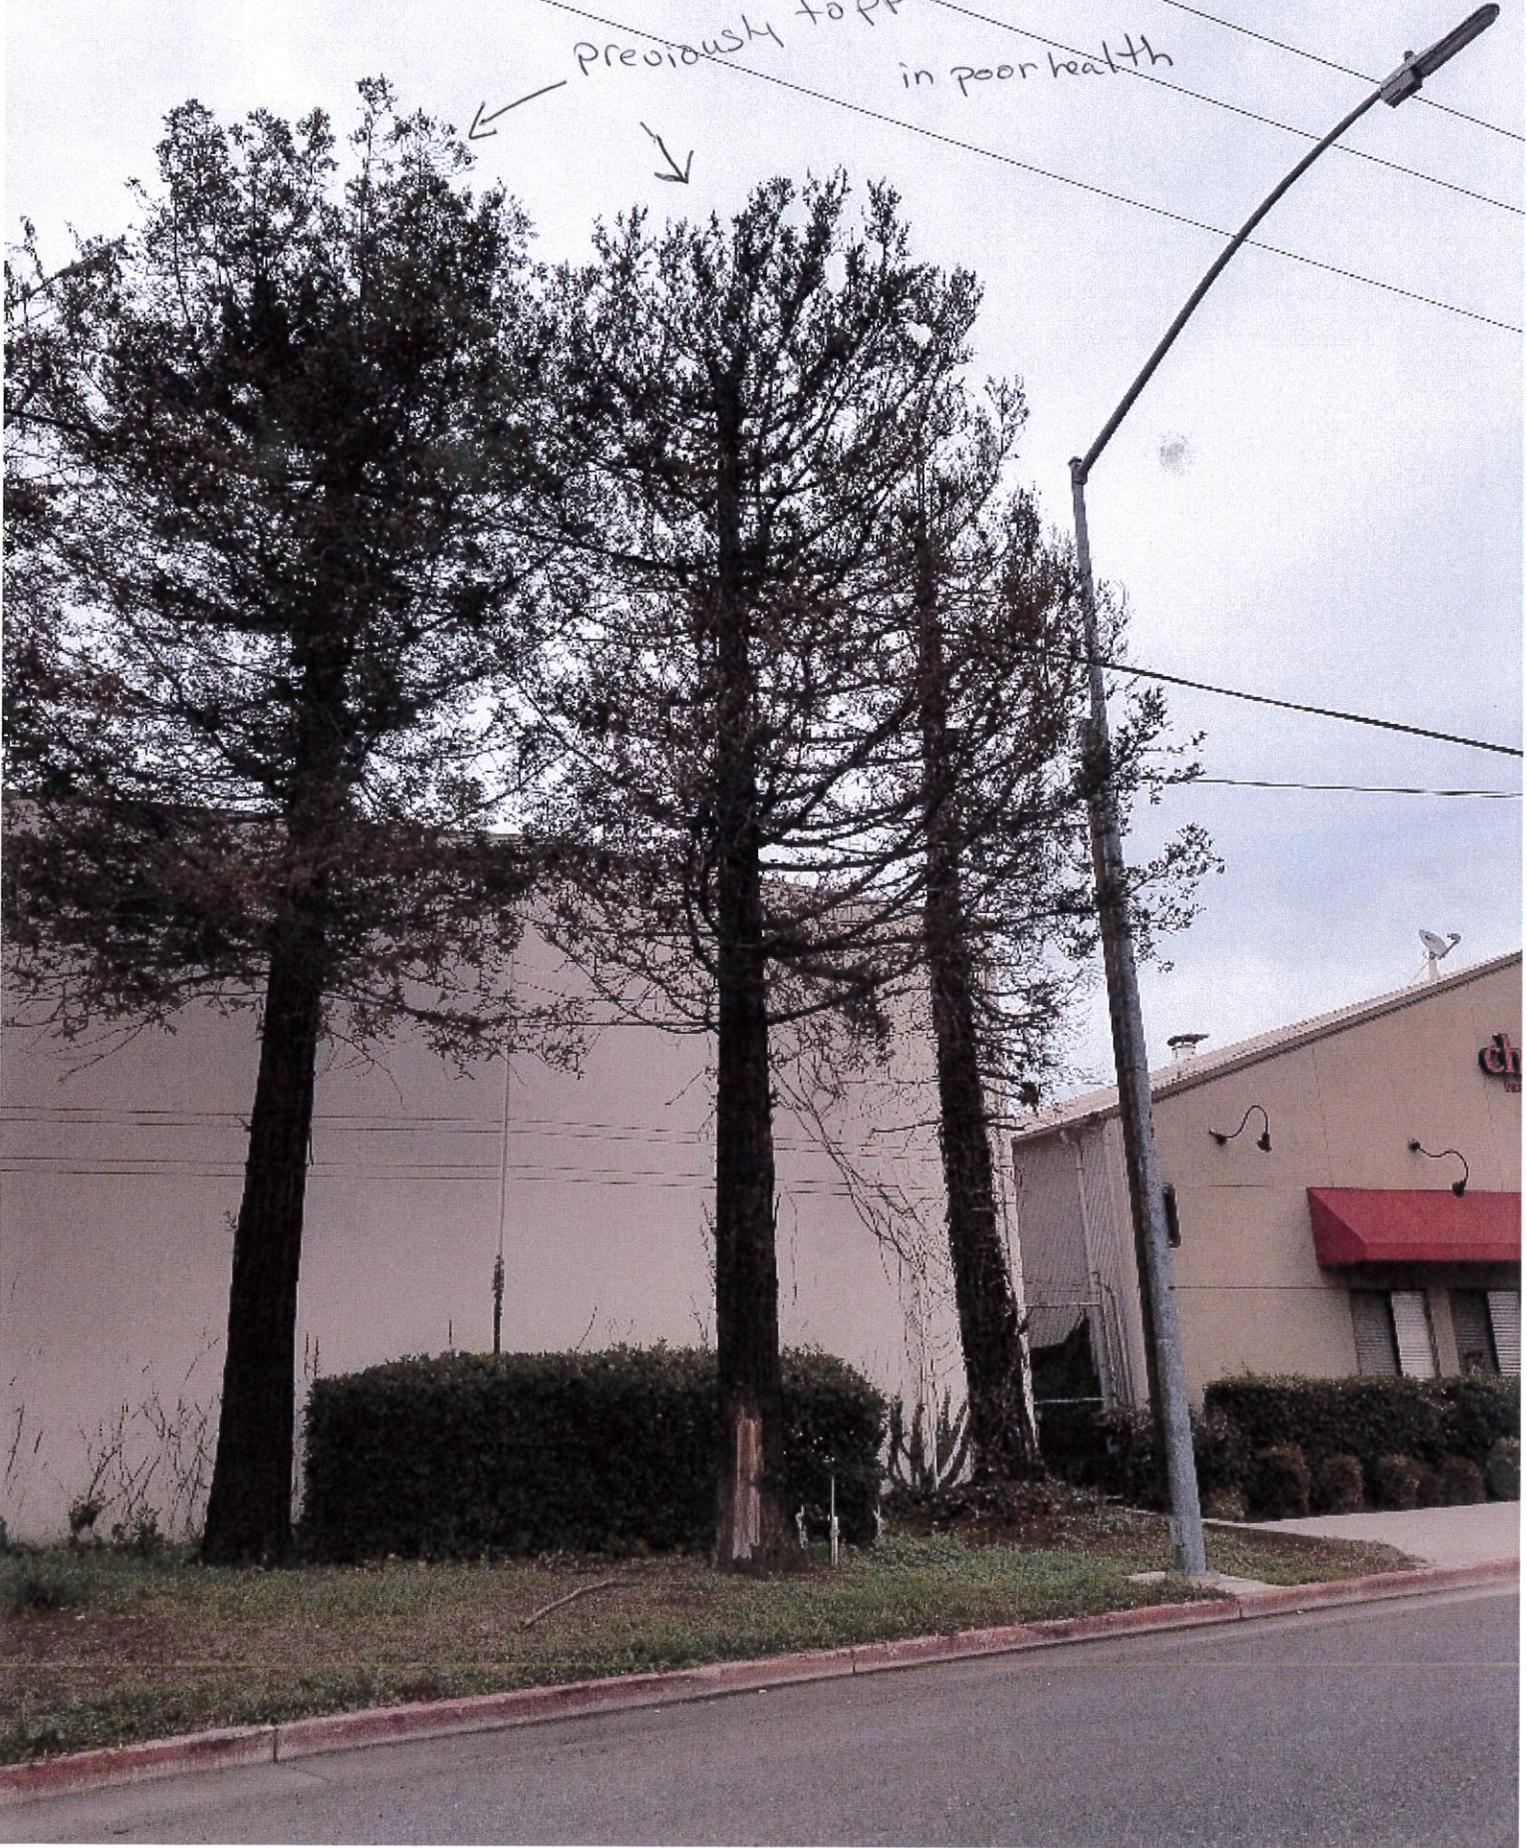
← previously topped by PG & E

- in poor health
- close building proximity
