CITY OF CAMPBELL
Community Development Department

NOTICE OF ADMINISTRATIVE ACTION

Project Address: 169 Redding Road (opposite 1400 Hoffman Ln)

Re: Written Statement- Chateaux Foret HOA- Common Area Oaks- Adjacent to 169 Redding Road

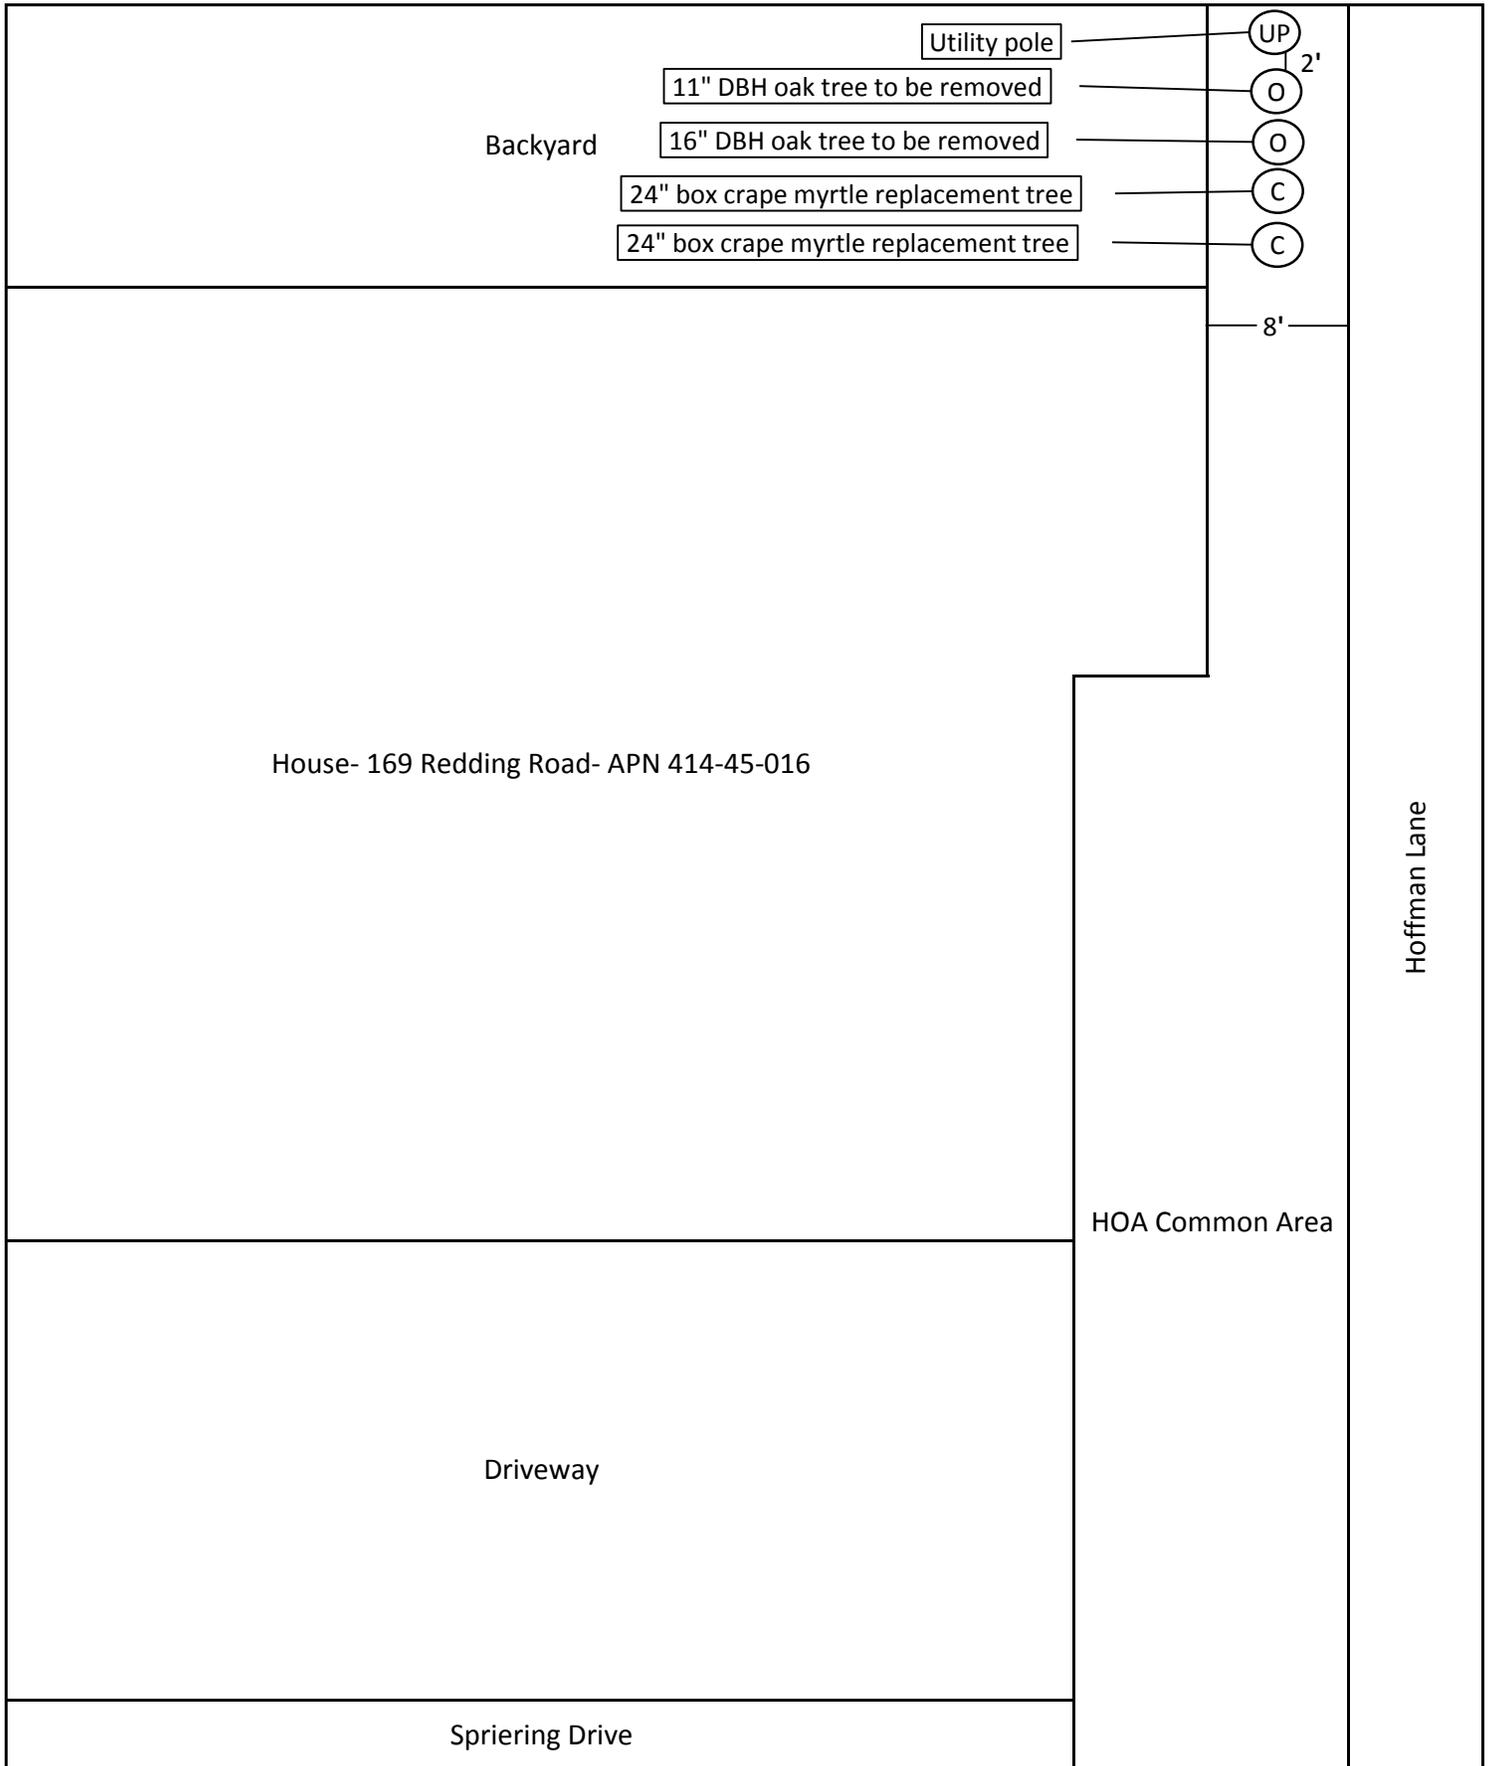
Tree Removal and Replacement Plan

Oak #1 has a diameter of 11 inches measured at four and one half feet above grade, or diameter at breast height (DBH). Oak #1 has an approximate crown height and crown spread estimated at 30 and 25 feet, respectively. Oak #1 is located in the HOA common area along Hoffman Lane adjacent to a PG&E utility pole (1'), cinder block retaining wall (2') and under high voltage utility lines (see *Tree Photographs* submitted with the online Tree Removal Permit Application).

Oak #2 has a DBH of 16 inches and an approximate crown height and crown spread estimated at 30 and 25 feet, respectively. Oak #2 is located 12 feet to the south of Oak #1. Oak #2 is located in the HOA common area along Hoffman Lane adjacent to a PG&E utility pole (13'), cinder block retaining wall (<2') and under high voltage utility lines (see *Tree Photographs* submitted with the online Tree Removal Permit Application).

Both oaks have been topped/hard-pruned to approximately 30 feet above grade to provide clearance for the utility lines above. As a result, the oaks exhibit structure damage in terms of form, in addition to the large wounds created from the numerous topping cuts. These large cuts will have difficulty compartmentalizing the decay, which will compromise the structural integrity of the trees.

Both oaks also have a significant crown imbalance. They both have been topped. They have also been side-pruned on the homeowner side (west side), apparently to provide clearance for their backyard. Oak # 1 is also in close proximity to the utility pole. As a result, it has been

additionally side-pruned to provide clearance for the utility pole. The predominant percentage of the crown of each oak is extending over Hoffman Lane. As the oaks mature, the potential for tree failure will increase in direct proportion with the increase in crown weight.

Both oaks have Codominant Stems with included bark. Codominant Stems is a structural deficiency inherent in some species of trees, particularly oaks. The branching pattern produces multiple branches from a relatively short trunk span. As these branches grow in diameter, they crowd each other off the trunk, weakening branch attachments and developing growth patterns in a way that is unsustainable for the limbs to coexist in the long-term. As a result, the trees have a propensity for splitting apart, sometimes losing as much as one-half of their tree crown and trunk diameters in a single event.

Based upon the evaluation detailed above, both oaks present safety concerns. The oaks have structural defects that cannot be corrected and are prone to failure. There are no mitigation efforts to address these deficiencies. Such trees should not be preserved in areas near a public street where injury to passersby and damage to vehicles is amplified. The oaks will assuredly grow in size and, as a result, their potential for damage will also grow. I recommend removal of and replacement of the oaks with a species better-suited for the location.
