**NOTICE OF INTENT
INTENT TO ADOPT A MITIGATED NEGATIVE DECLARATION
CITY OF CAMPBELL, CALIFORNIA**

Project Title: Abbott Avenue Subdivision

Historic Resource Evaluation

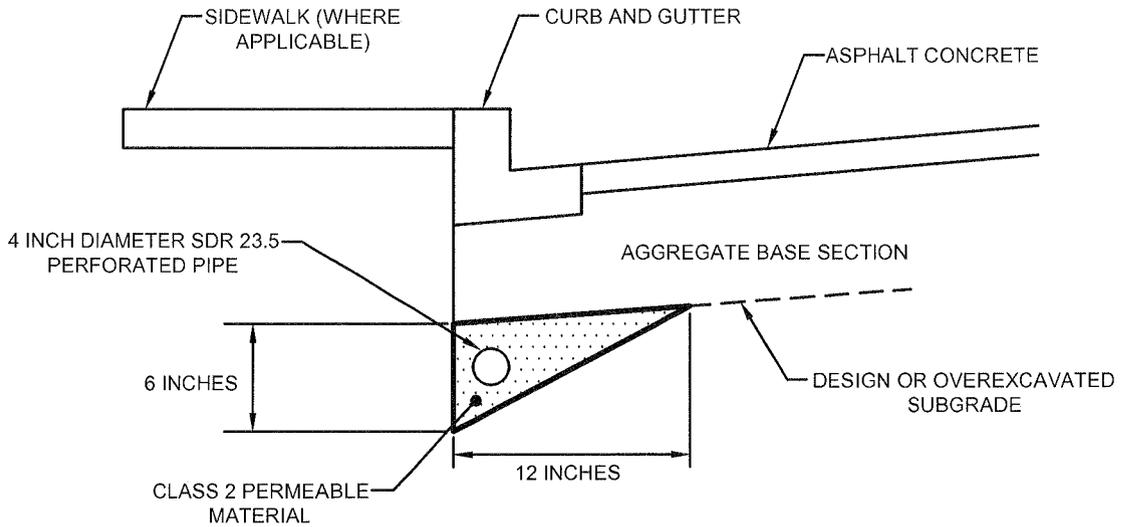
1. 4 INCH DIAMETER PERFORATED PIPE TO BE SURROUNDED BY AT LEAST 2 INCHES OF CLASS 2 PERMEABLE MATERIAL.
2. 4 INCH DIAMETER PERFORATED PIPE TO DISCHARGE INTO CATCH BASIN/DRAIN INLET.
3. PERFORATED PIPE TO BE LOCATED BELOW EXISTING SHALLOW UNDERGROUND UTILITIES WHERE THEY CROSS.

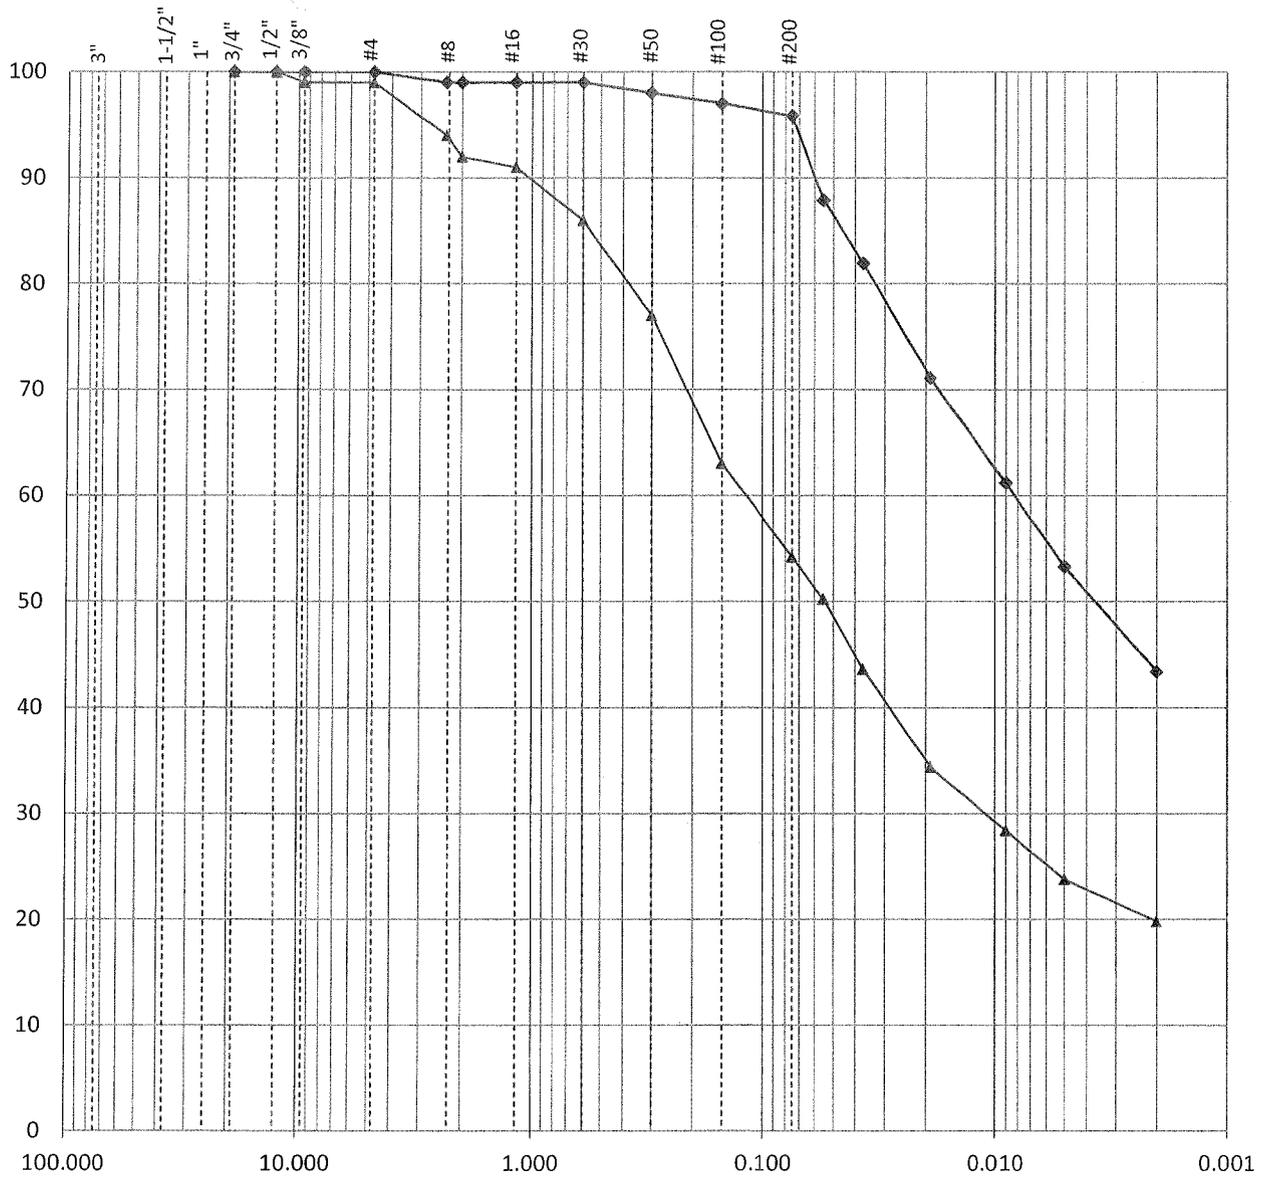
GRADATION TEST DATA

▲ B-1 at 2 feet ◆ B-4 at 5 feet

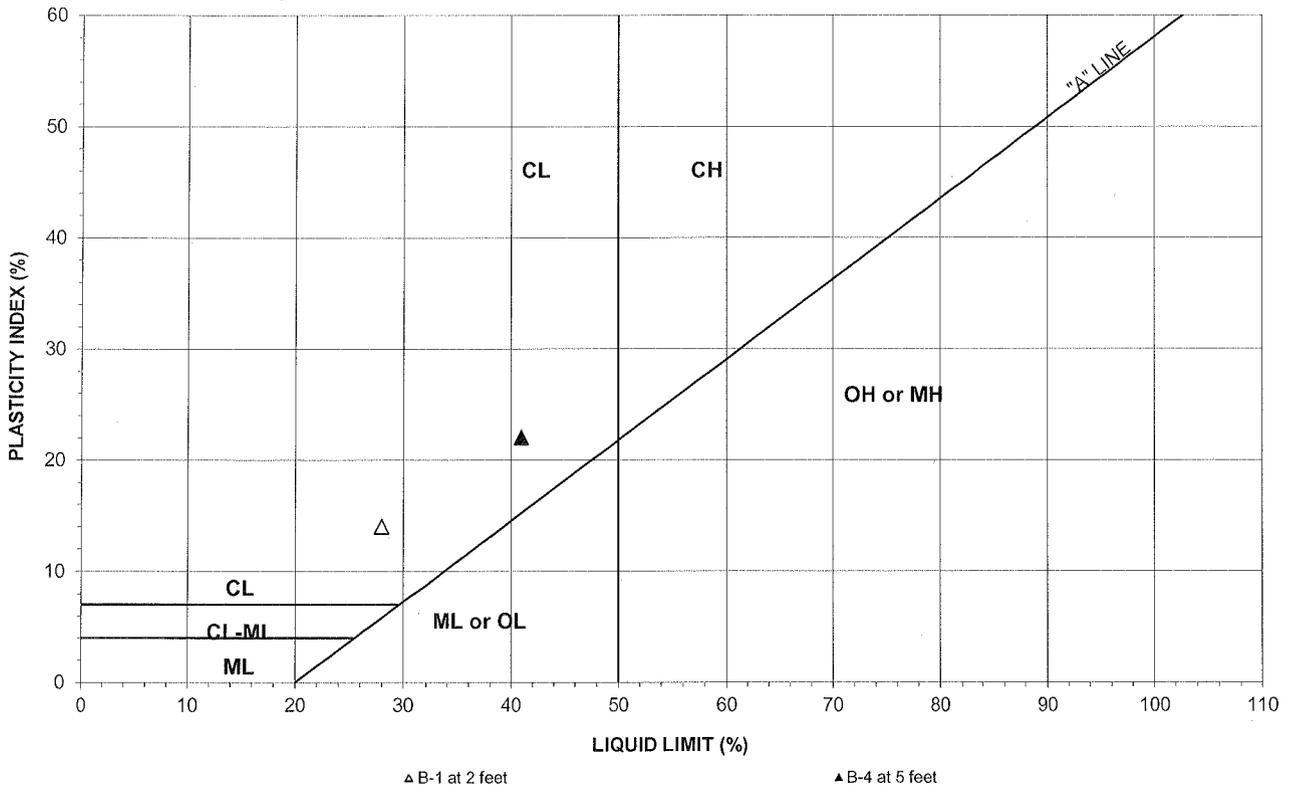
ATTERBERG LIMITS TEST

LOCATION	LIQUID LIMIT	PLASTICITY INDEX	USCS CLASSIFICATION
B-1 at 2 feet	28	14	CL
B-4 at 5 feet	41	22	CL

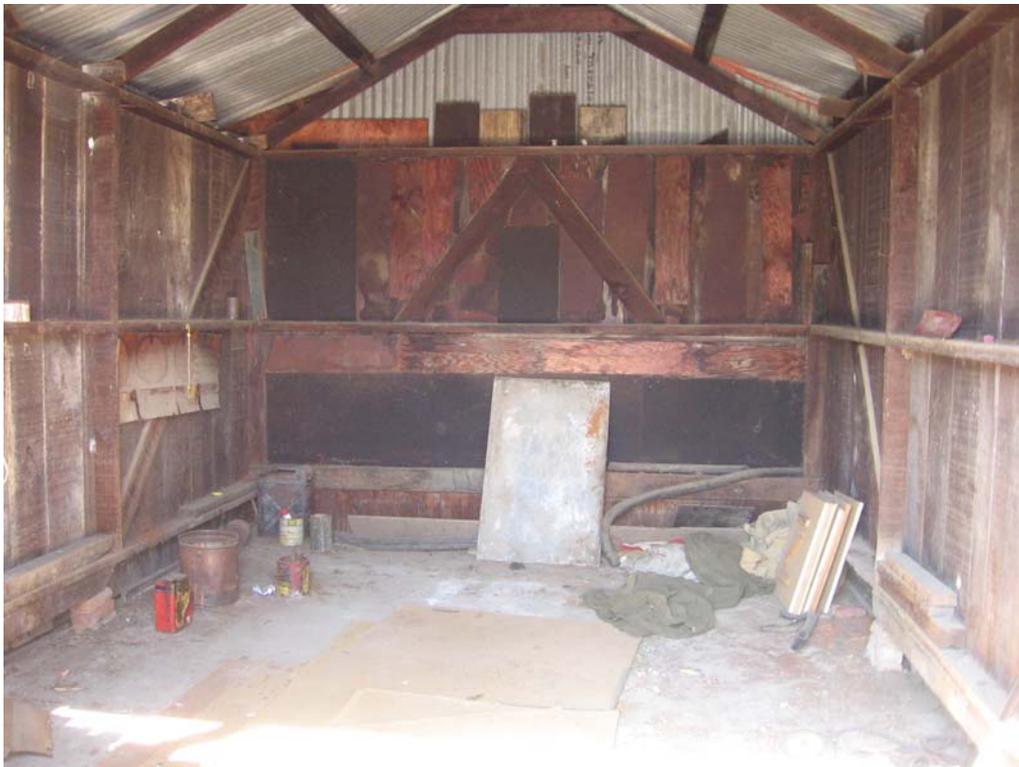
Photo 14, Interior of Shed 2B, looking west, typical; empty 5-gal. metal gas can in back corner (left)

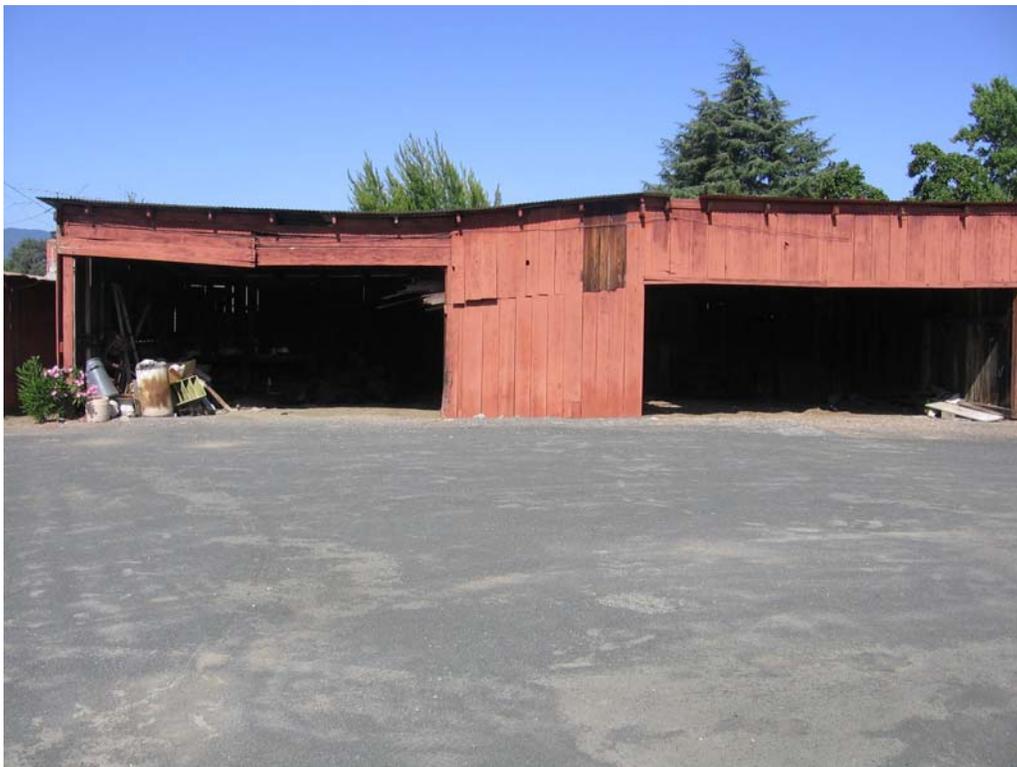
Photo 16, Exterior of Shed 3, looking west, Shed 3A on left (pile of garbage on left outside and inside Shed 3A), Shed 3B on right.

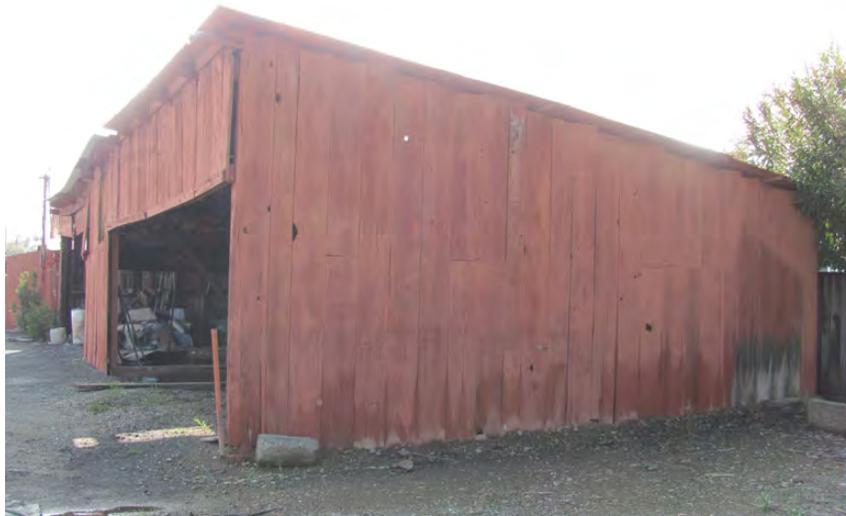
Figure 4. Shed 1, looking roughly south.

The northernmost storage shed (Shed 1) is rectangular in plan and topped by a corrugated metal clad shed roof. It has two open vehicular bays on the front (east) elevation and all other

walls are clad in vertical wood boards. Like the other two shed structures, the exterior of the building is painted brick red and the interior is generally unpainted.

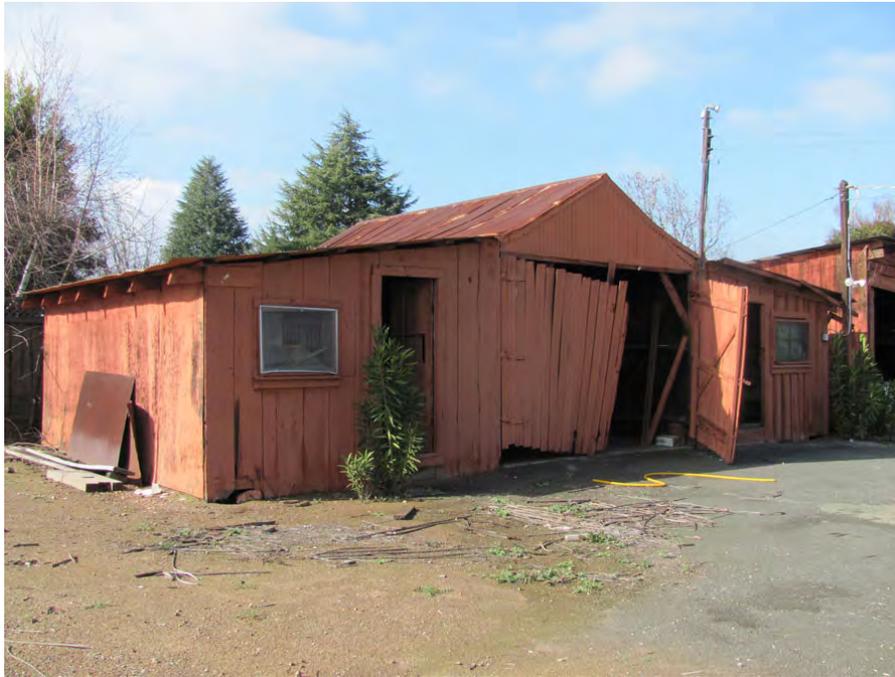
Figure 5. Shed 2, looking roughly NW.

The center outbuilding (Shed 2) is a front-facing gable roofed structure flanked by shed-roofed side bays. Corrugated metal covers the roof surfaces and the gable face. The northern wing of this structure may have at one time been used as a worker's cottage, as it is wired for electricity and had shelving and curtains. The front elevation has board and batten siding, but interior is otherwise unfinished. The central bay sits on a concrete slab and is accessed via two wood barn doors made up of narrow vertical strips of beadboard. The interior is unfinished and used for storage. The southern wing has walls of vertical wood boards and wood plywood sheets (south wall). It is accessed on the front (east) wall via an older wood panel door that is missing its glazing. This room is also used for storage.

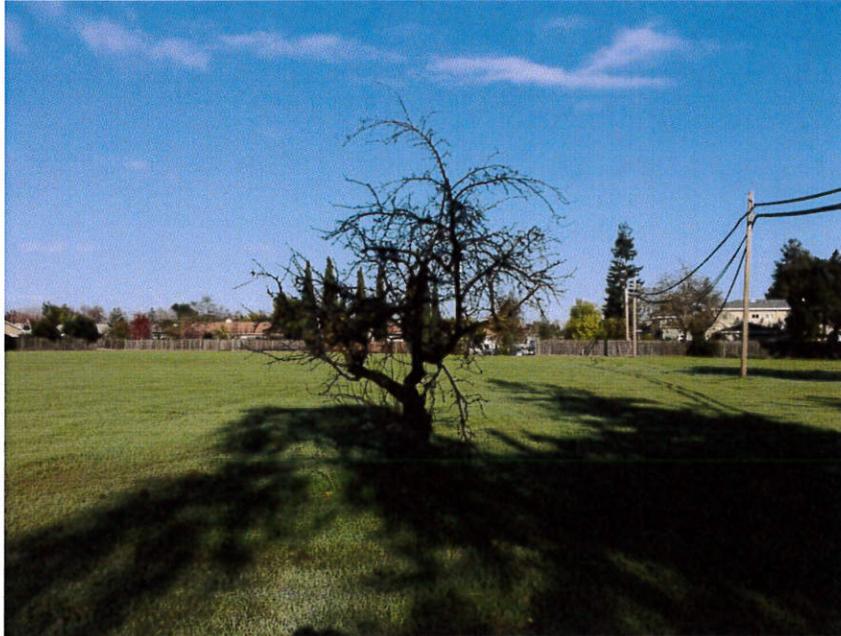
Tree 1

Trees #1 & 2 - European Plums (Stanley Variety – *Prunus domestica L.*) have a rating of (5) as they are both in Extremely Poor health, nearing or at the end of their lifespan with visible structural weakness and noted infestations.

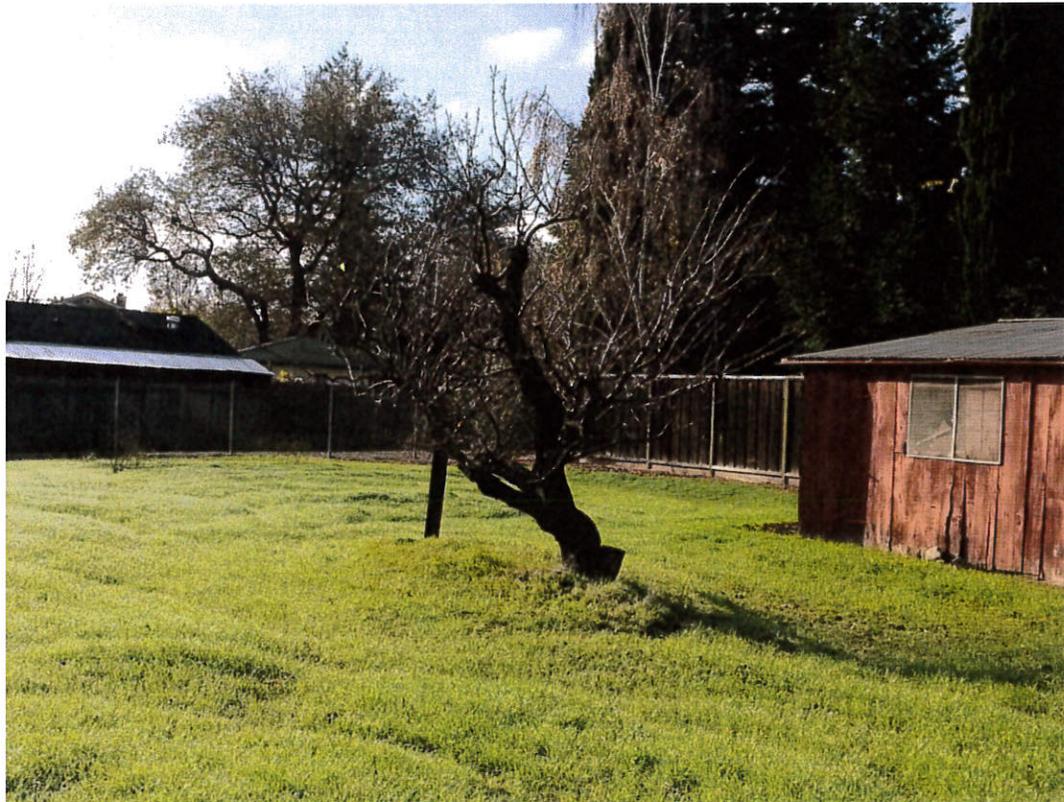
Tree 3

Tree # 3 - Apricot (Blenheim Variety – *Prunus armeniaca L.*) has a rating of (5) as it is in Extremely Poor health nearing or at the end of its lifespan with visible structural weakness noted by board supporting tree as well as noted infestation.

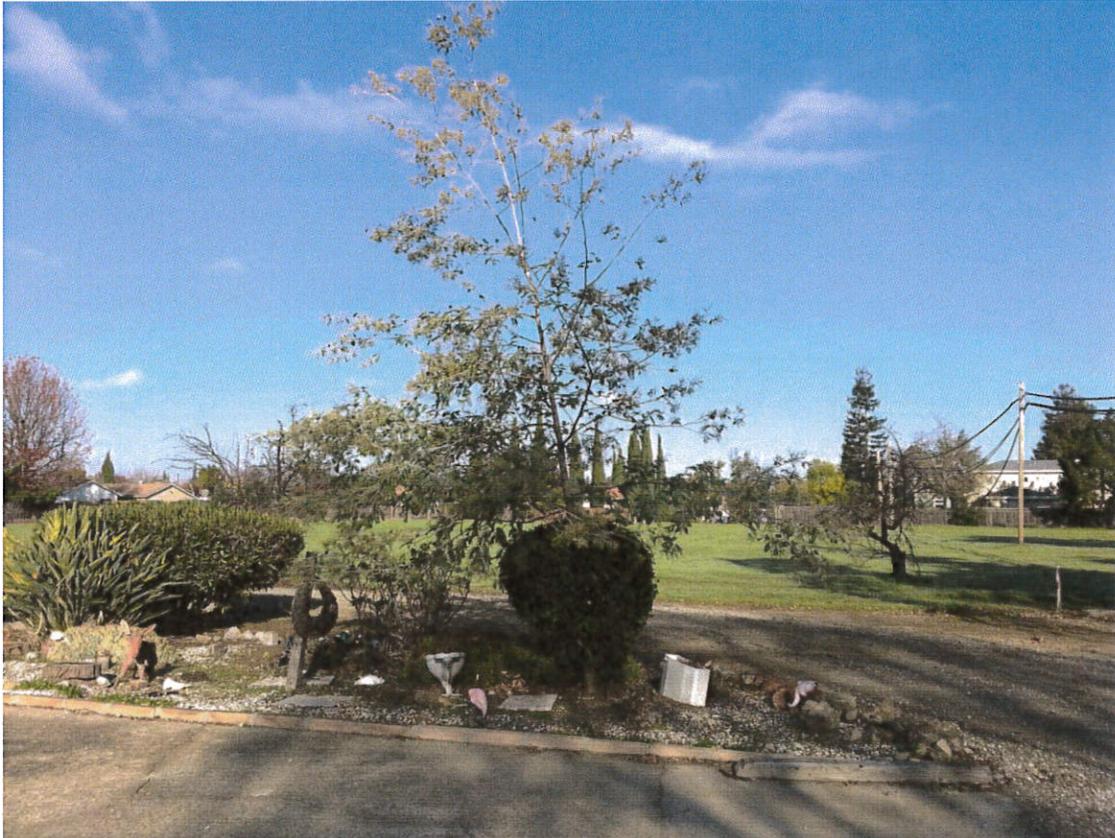
Tree 4

Tree # 4 - Kelly's Gold Box Elder Maple (*Acer negundo*) has a rating of (3) and while it has no visible structural weakness, the tree is leaning significantly, potentially indicating a poor root structure and doesn't appear well adapted for it's location.

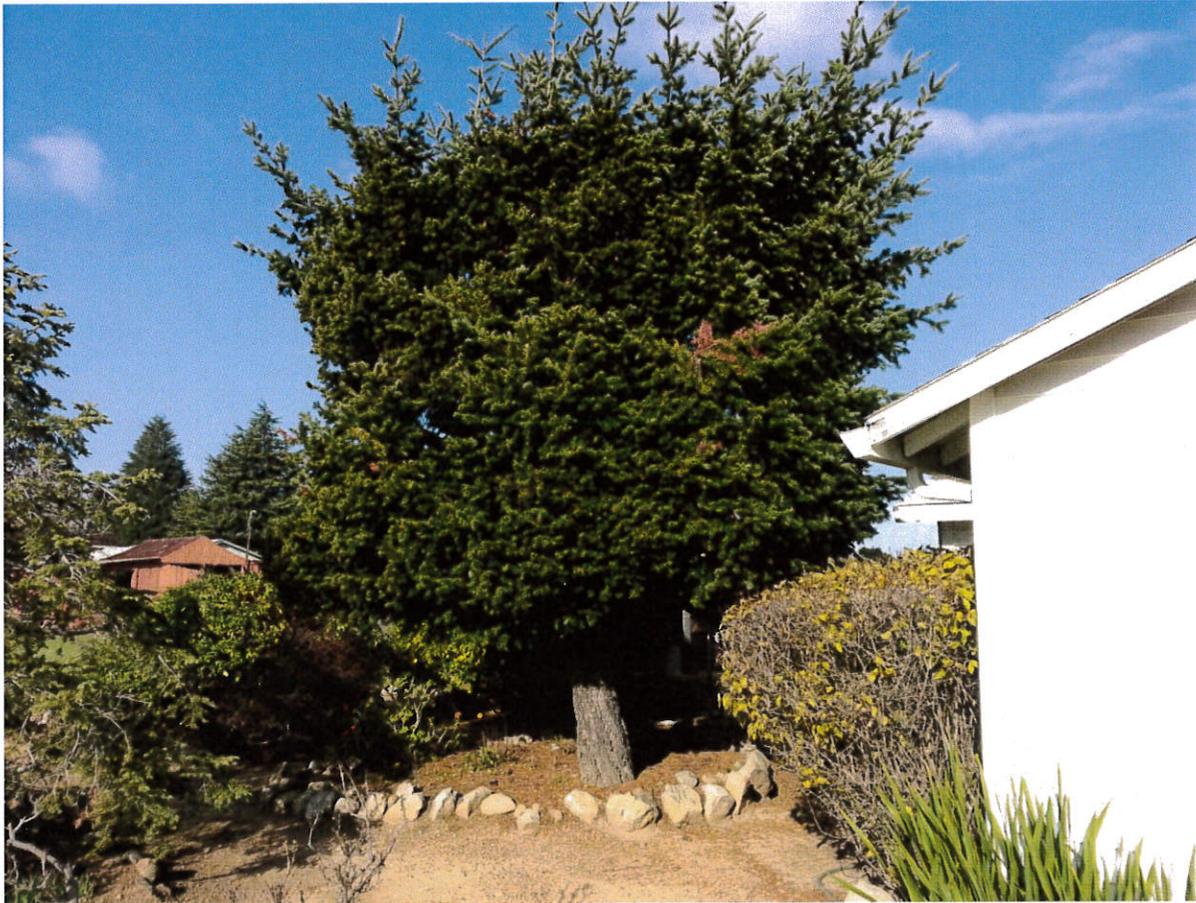
Tree 5

Tree # 5 – Fraser Fir (*Abies Fraseri*) has a rating of (4) due to its age, evidence of beetle infestation and the owners topping practice. “Topping” permanently changes the structural integrity of trees. After having been topped, they must be pruned every 1-2 years for their entire lives to reduce the risk of limb failure. While not typical of a Fir tree to suffer limb failure, it is important to note that this particular tree suffers from its owners pruning technique and while not at imminent risk, is nearing the end of its life.

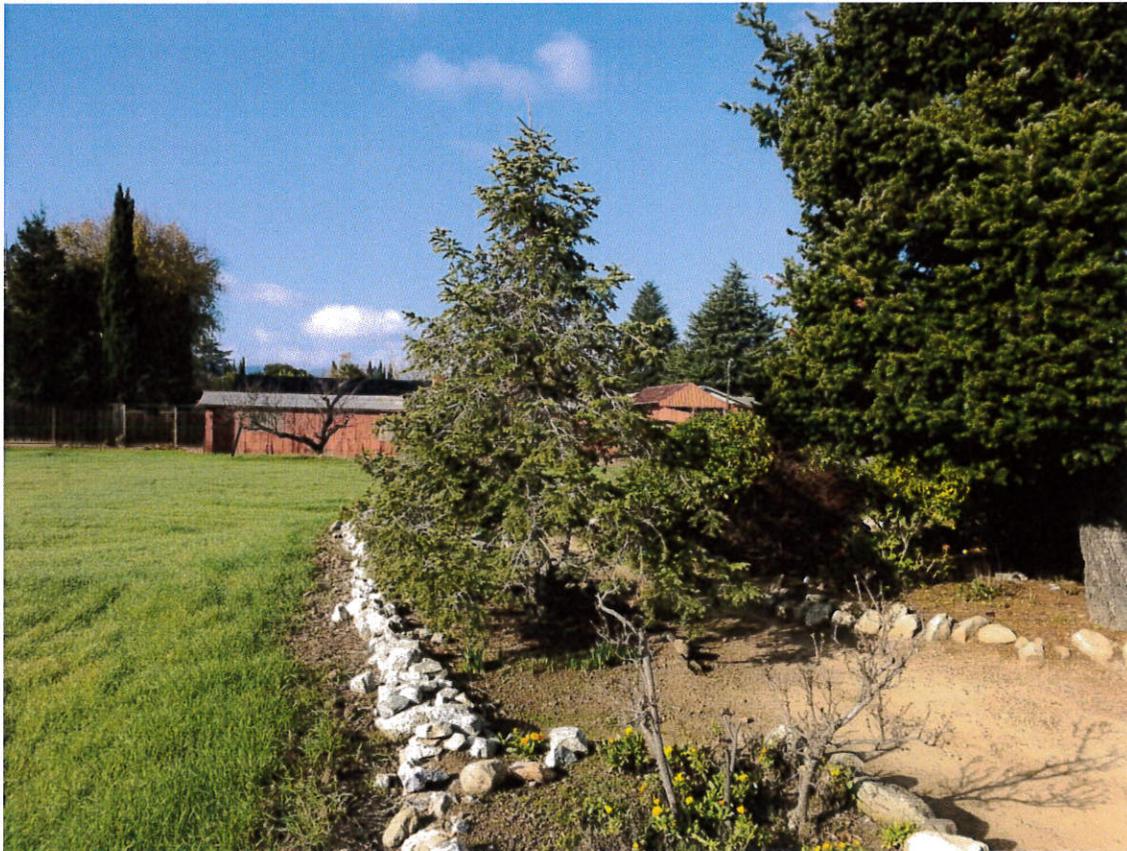
Tree 6

Tree # 6 – Noble Fir (*Abies procera* Rehd.) has a rating of (5) due to its age and condition. While technically a tree, what you see is a vertical outgrowth, sometimes referred to as a “sucker” that has grown from the trunk which at some point had been cut down for reasons unknown. The main trunk system appears to be somewhere around 30-50 years old, and while this outgrowth is currently alive, it appears the root structure and trunk system is not capable of achieving growth and height greater than its current size. This tree appears to be nearing the end of its life.

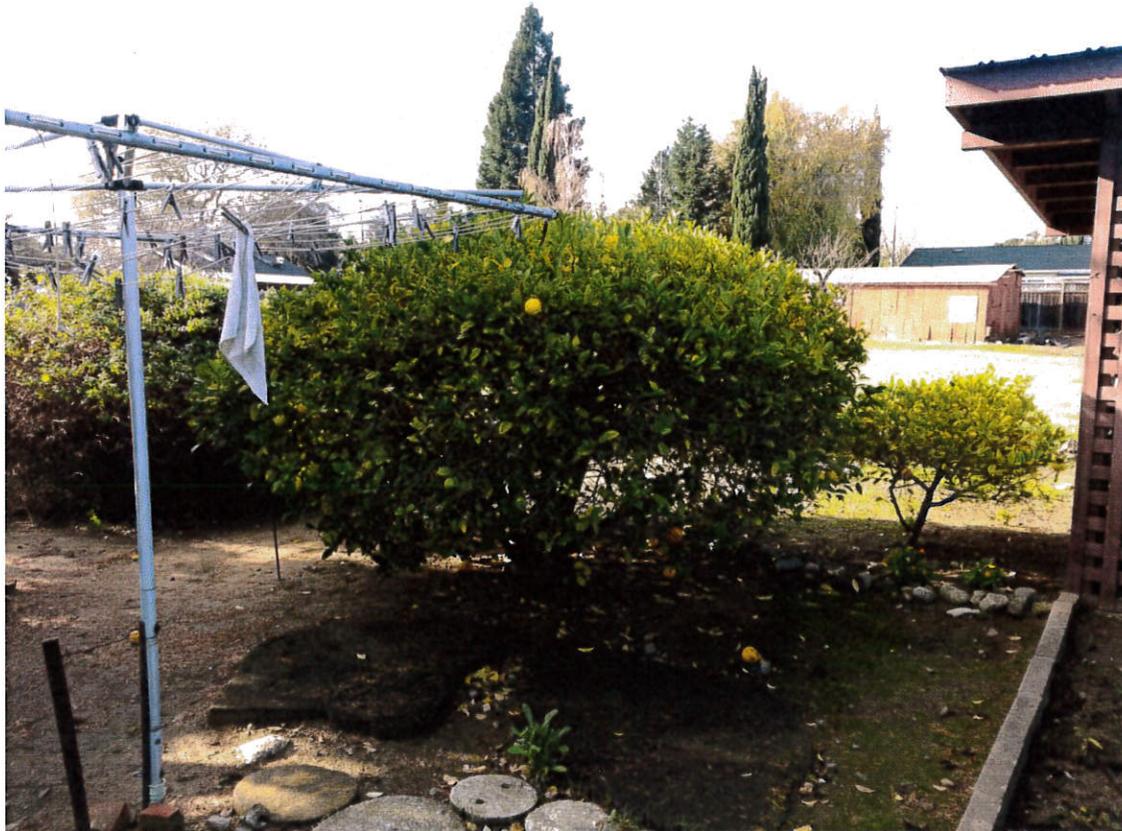
Tree 7

Tree # 7 – Eureka Lemon (*Citrus limon L.*) has a rating of (3) and while not properly pruned and cared for, appears to be in fair condition overall. This tree also demonstrated topping characteristics. “Topping” permanently changes the structural integrity of trees. After having been topped, they must be pruned every 1-2 years for their entire lives to reduce the risk of limb failure.
