**CEQA DOCUMENT DECLARATION**

1. LEAD AGENCY: City of Campbell
2. PROJECT TITLE: Dillon Avenue Townhomes and Apartments
3. APPLICANT NAME: Santa Clara Development / Robson Homes PHONE: (408) 345-1767
4. APPLICANT ADDRESS: 2185 The Alameda, San Jose, CA 95126
5. PROJECT APPLICANT IS A: ☐ Local Public Agency ☐ School District ☐ Other Special District ☐ State Agency ☒ Private Entity
6. NOTICE TO BE POSTED FOR 24 DAYS.

The Community Development Department has prepared an Infill Environmental Checklist in compliance with State CEQA Guideline Sec. 15183.3 for the purposes of determining whether the proposed infill project described below may have a significant effect on the environment not addressed in a previous Environmental Impact Report (EIR), not substantially mitigated by uniformly applicable development policies, or mitigated through project-specific measures. "Significant effect on the environment" means a substantial, or potentially substantial, adverse change in any of the physical conditions within the area affected by the project including land, air, water, minerals, flora, fauna, ambient noise, and objects of historic or aesthetic significance.

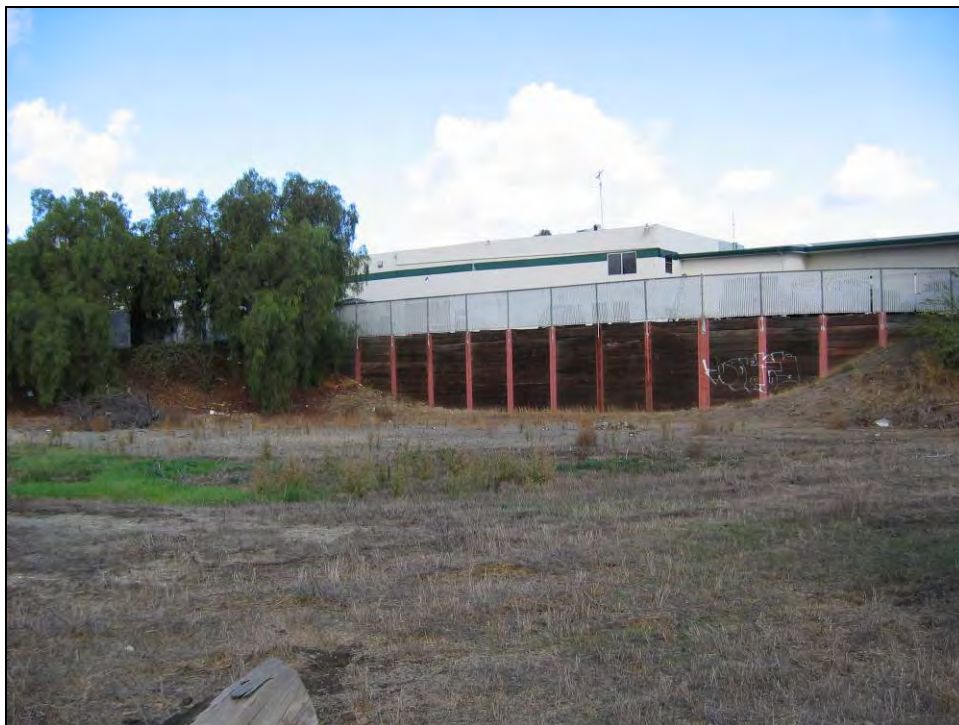
VIEW OF THE SITE LOOKING NORTHERLY

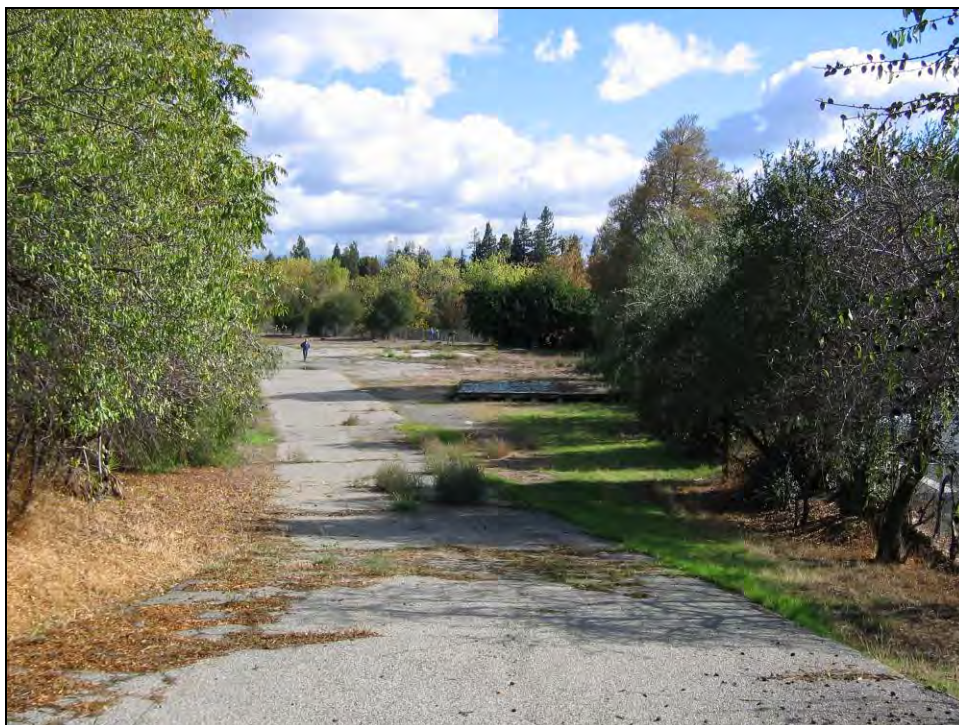
VIEW OF THE SITE LOOKING EASTERLY

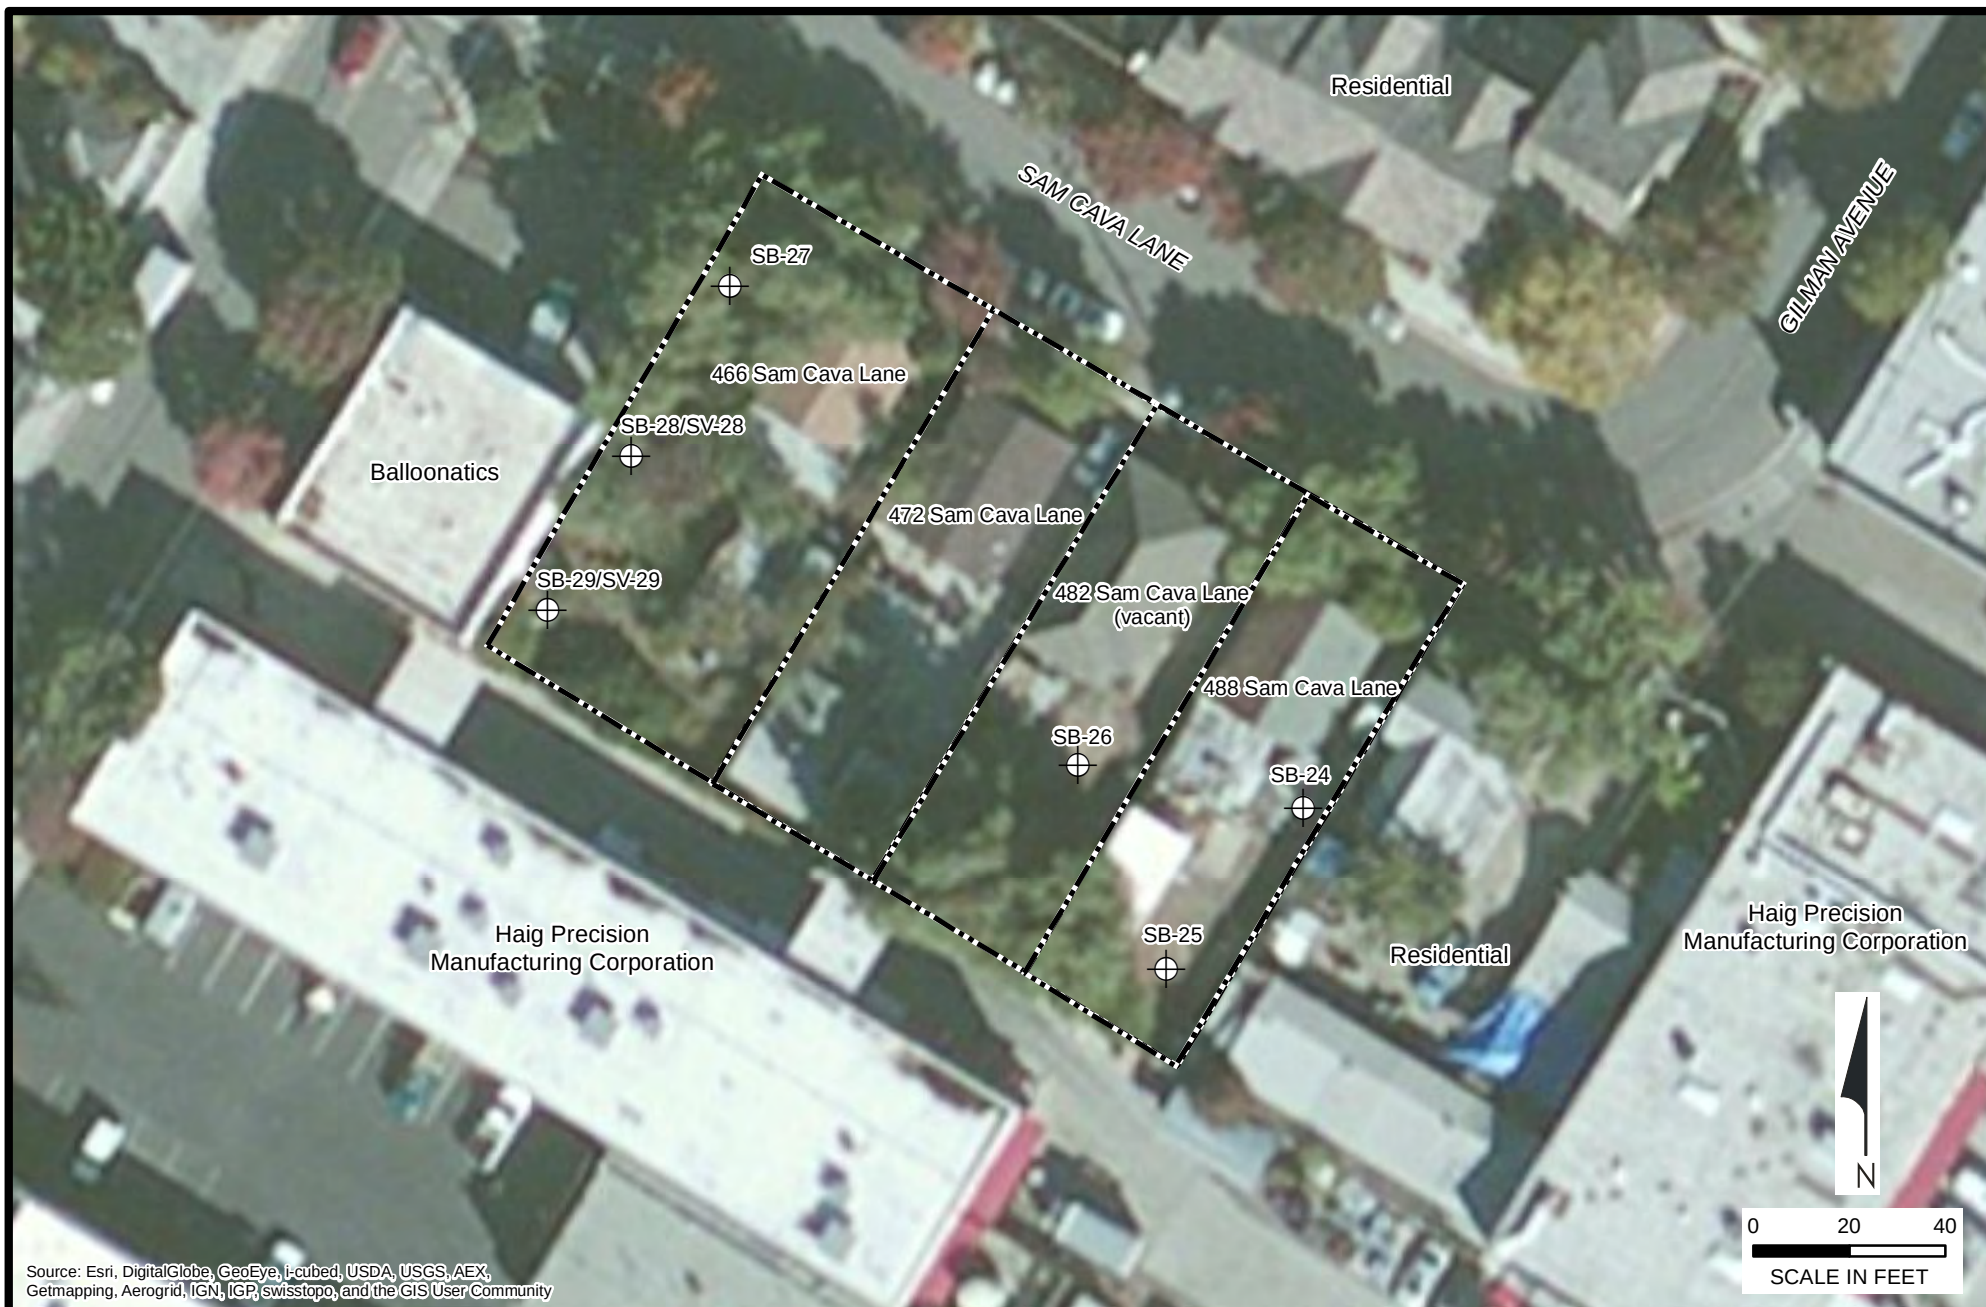
**Site Layout and Sampling Locations**  
Hester Properties  
466, 472, 482, and 488 Sam Cava Lane  
Campbell, California
