CITY OF CAMPBELL
Community Development Department

**ADDENDUM TO A MITIGATED NEGATIVE DECLARATION (MND)
AND INFILL ENVIRONMENTAL CHECKLIST**

**The Dillon Avenue Townhomes and Apartments Project (Revised)
280 Dillon Avenue et al.**

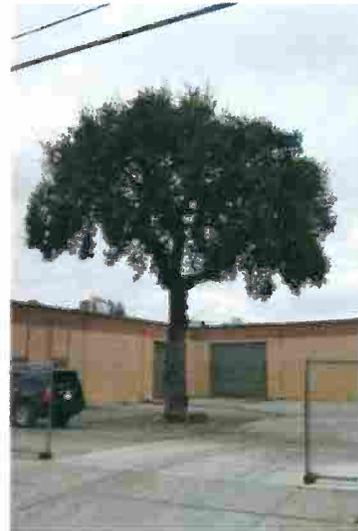
Photo 1: Coast Live Oak on 240 Dillon Avenue

The coast live oak has a trunk diameter of 34 inches at 4 feet above grade and is approximately 40 feet tall. The crown spreads approximately 15 feet in all directions and foliar size, color, and density are normal for the species. The tree has a live crown ratio of approximately 50 percent. All the branches have been headed back or topped to create a uniform unnatural rounded crown appearance. The crown consists primarily of adventitious branches that have sprouted from the heading or topping cuts and they all originate from three primary scaffold branches. The trunk is straight and void of foliage with several wounds, abnormal bark growth and color, and some exposed heartwood. There are two cankers on the lower trunk and some black oozing from a mechanical wound on the lower stem. The trunk flare is buried and there are no visible buttress roots, structural roots or above ground roots. The soil surface under the tree is covered in weed abatement material and medium sized cobbles. There is limited soil volume and the potential root zone, including the area within the drip line, is covered in concrete.

A tree's condition is a determination of its overall health and structure based on five aspects: roots, trunk, scaffold branches, twigs, and foliage. The assessment considered both the health and structure of the tree for a combined condition rating. The crown, trunk, trunk flare, and above ground roots were inspected from the ground (Tree Care Industry Association, 2011). The tree is in fair condition with at least one structural defect or health concern. The topped branches in the crown have created the need to continually maintain the tree by arbitrarily reducing the crown size or length of branches. If the tree is retained and not continually maintained the adventitious branches will grow larger and become prone to tearing off because of their weak attachments. Conversely, a restoration pruning regime would be expensive and time consuming.

A tree's suitability for preservation is determined based on its health, structure, age, species characteristics, and longevity using a scale of good, fair, or poor. The tree is poorly suited for preservation because the individual specimen is unsuited for the intended future use of the site (Tree Care Industry Association, 2012). Because the tree has been poorly managed and the damage from arbitrarily pruning the tree to a predetermined crown size would require extensive future management, the tree is not suitable to retain. There are signs of disease with a canker on the main stem as well.

In conclusion the tree is in fair condition but poorly suited for preservation. The conditions and defects the tree processes cannot be reasonably mitigated without extensive intervention over a long period of restoration pruning. The canker on the lower stem may be an indication of greater stem or root zone issues.

If the property is to be redeveloped I recommend removing the tree and focusing resources on replanting and establishing better specimens, in desired locations, with a greater overall contribution and value to the community.

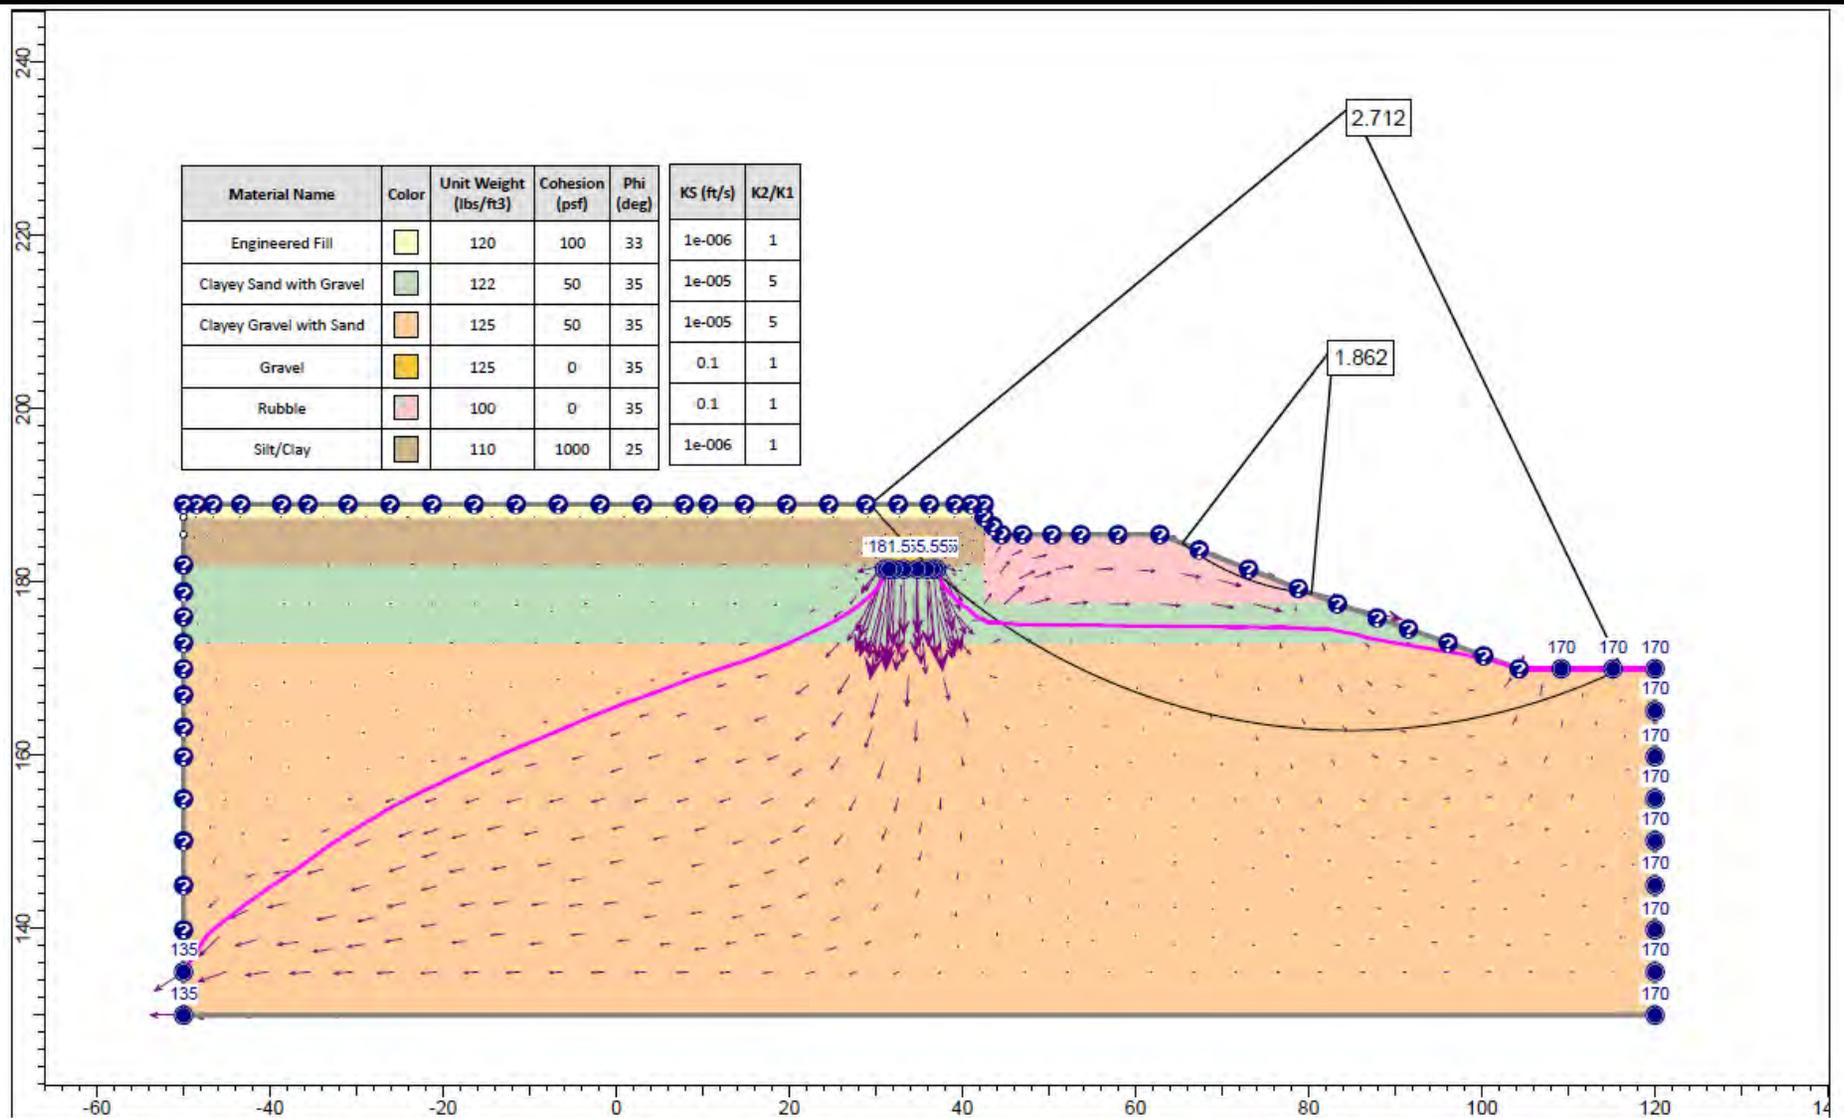
**FIGURE
1
PROJECT
2014.0005**

**SLOPE STABILITY ASSESSMENT
(STATIC CONDITION)
DILLON AVENUE PHASE I PROJECT
CAMPBELL, CALIFORNIA**

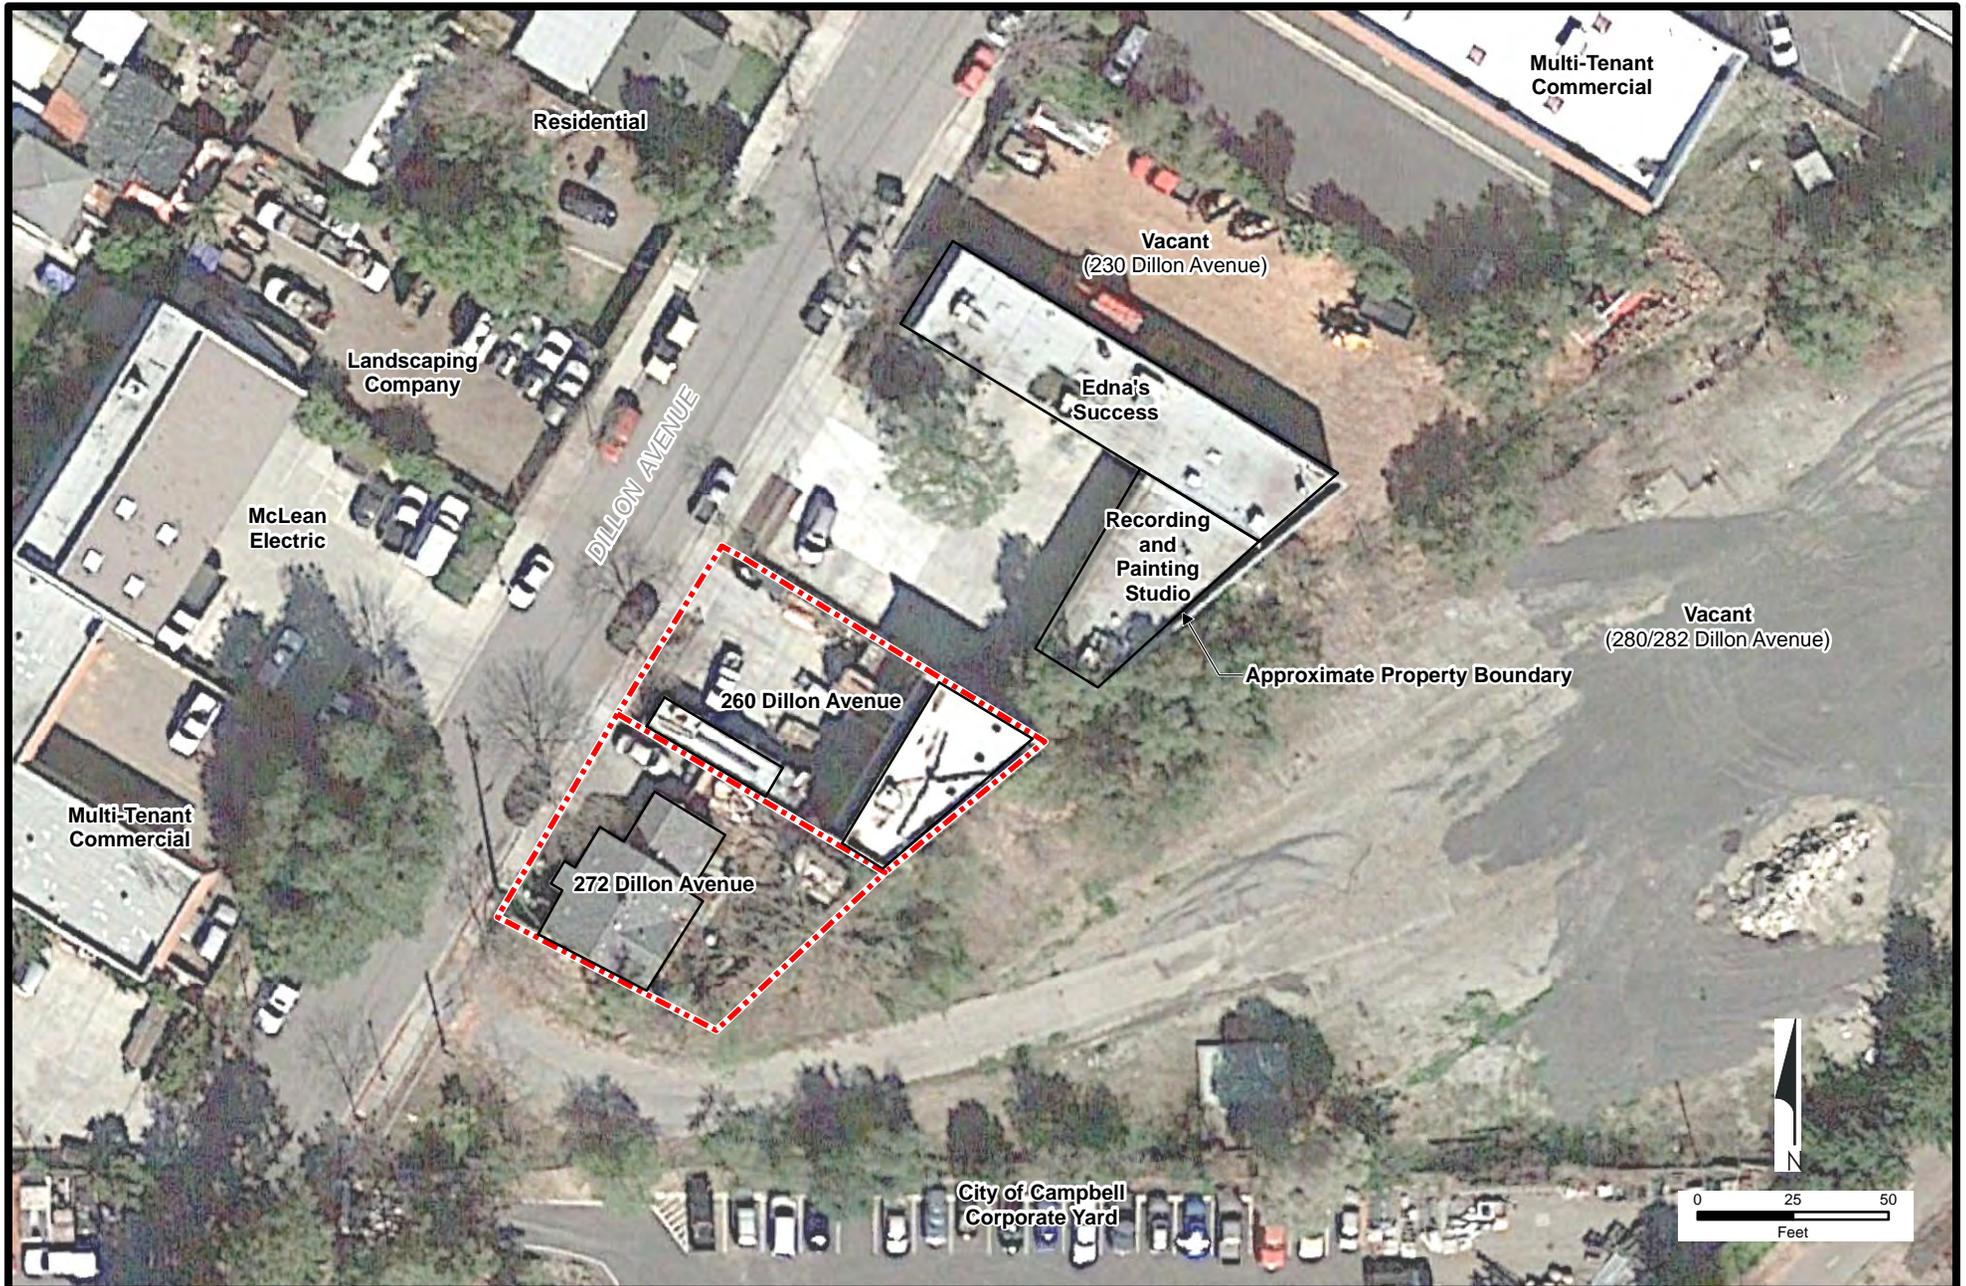
Figure

Site Layout
 260 and 272 Dillon Avenue
 Campbell, California

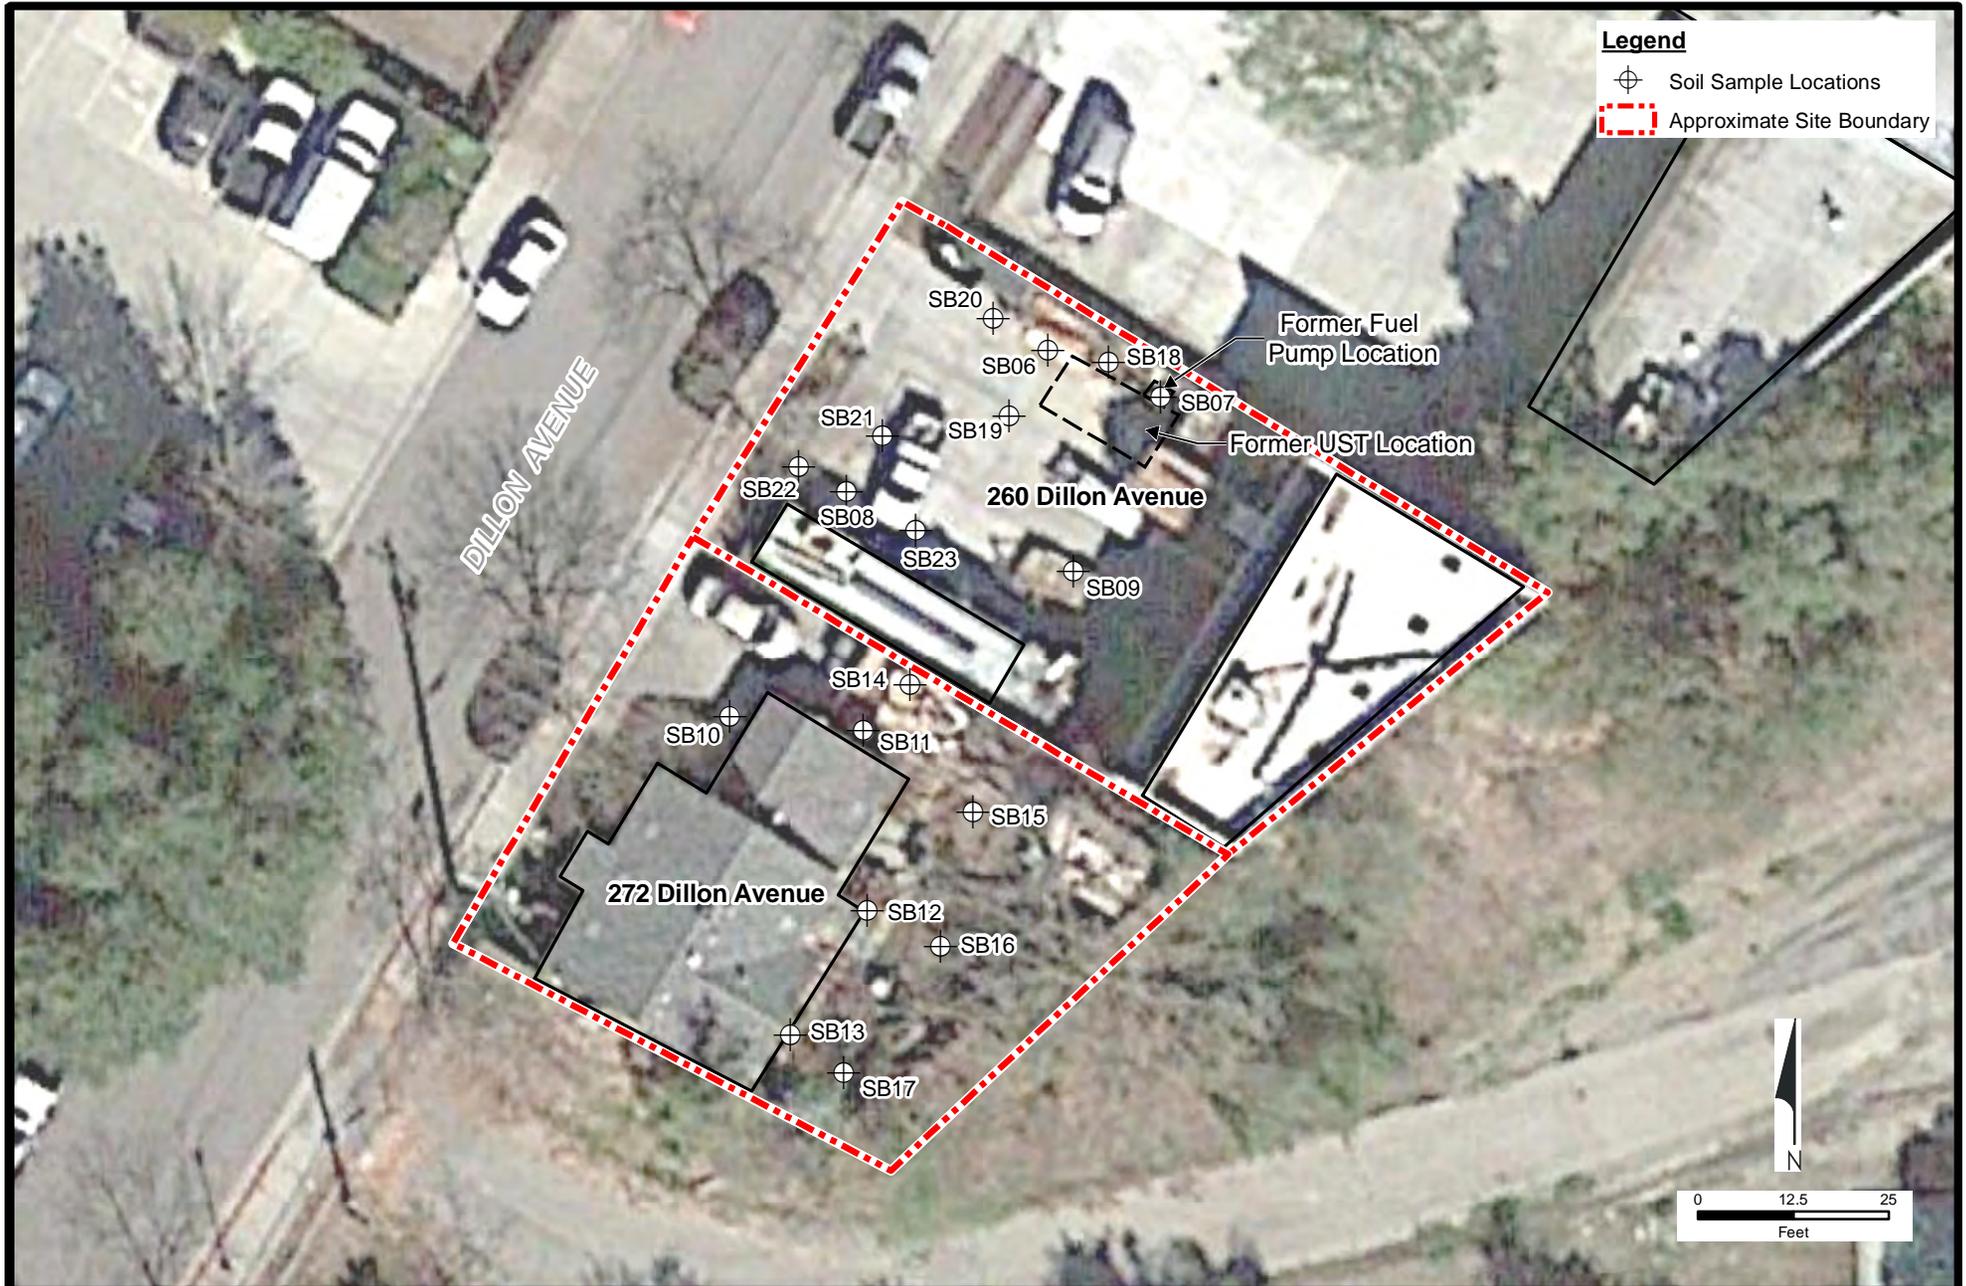
Figure

Sampling Location Map
 260 and 272 Dillon Avenue
 Campbell, California

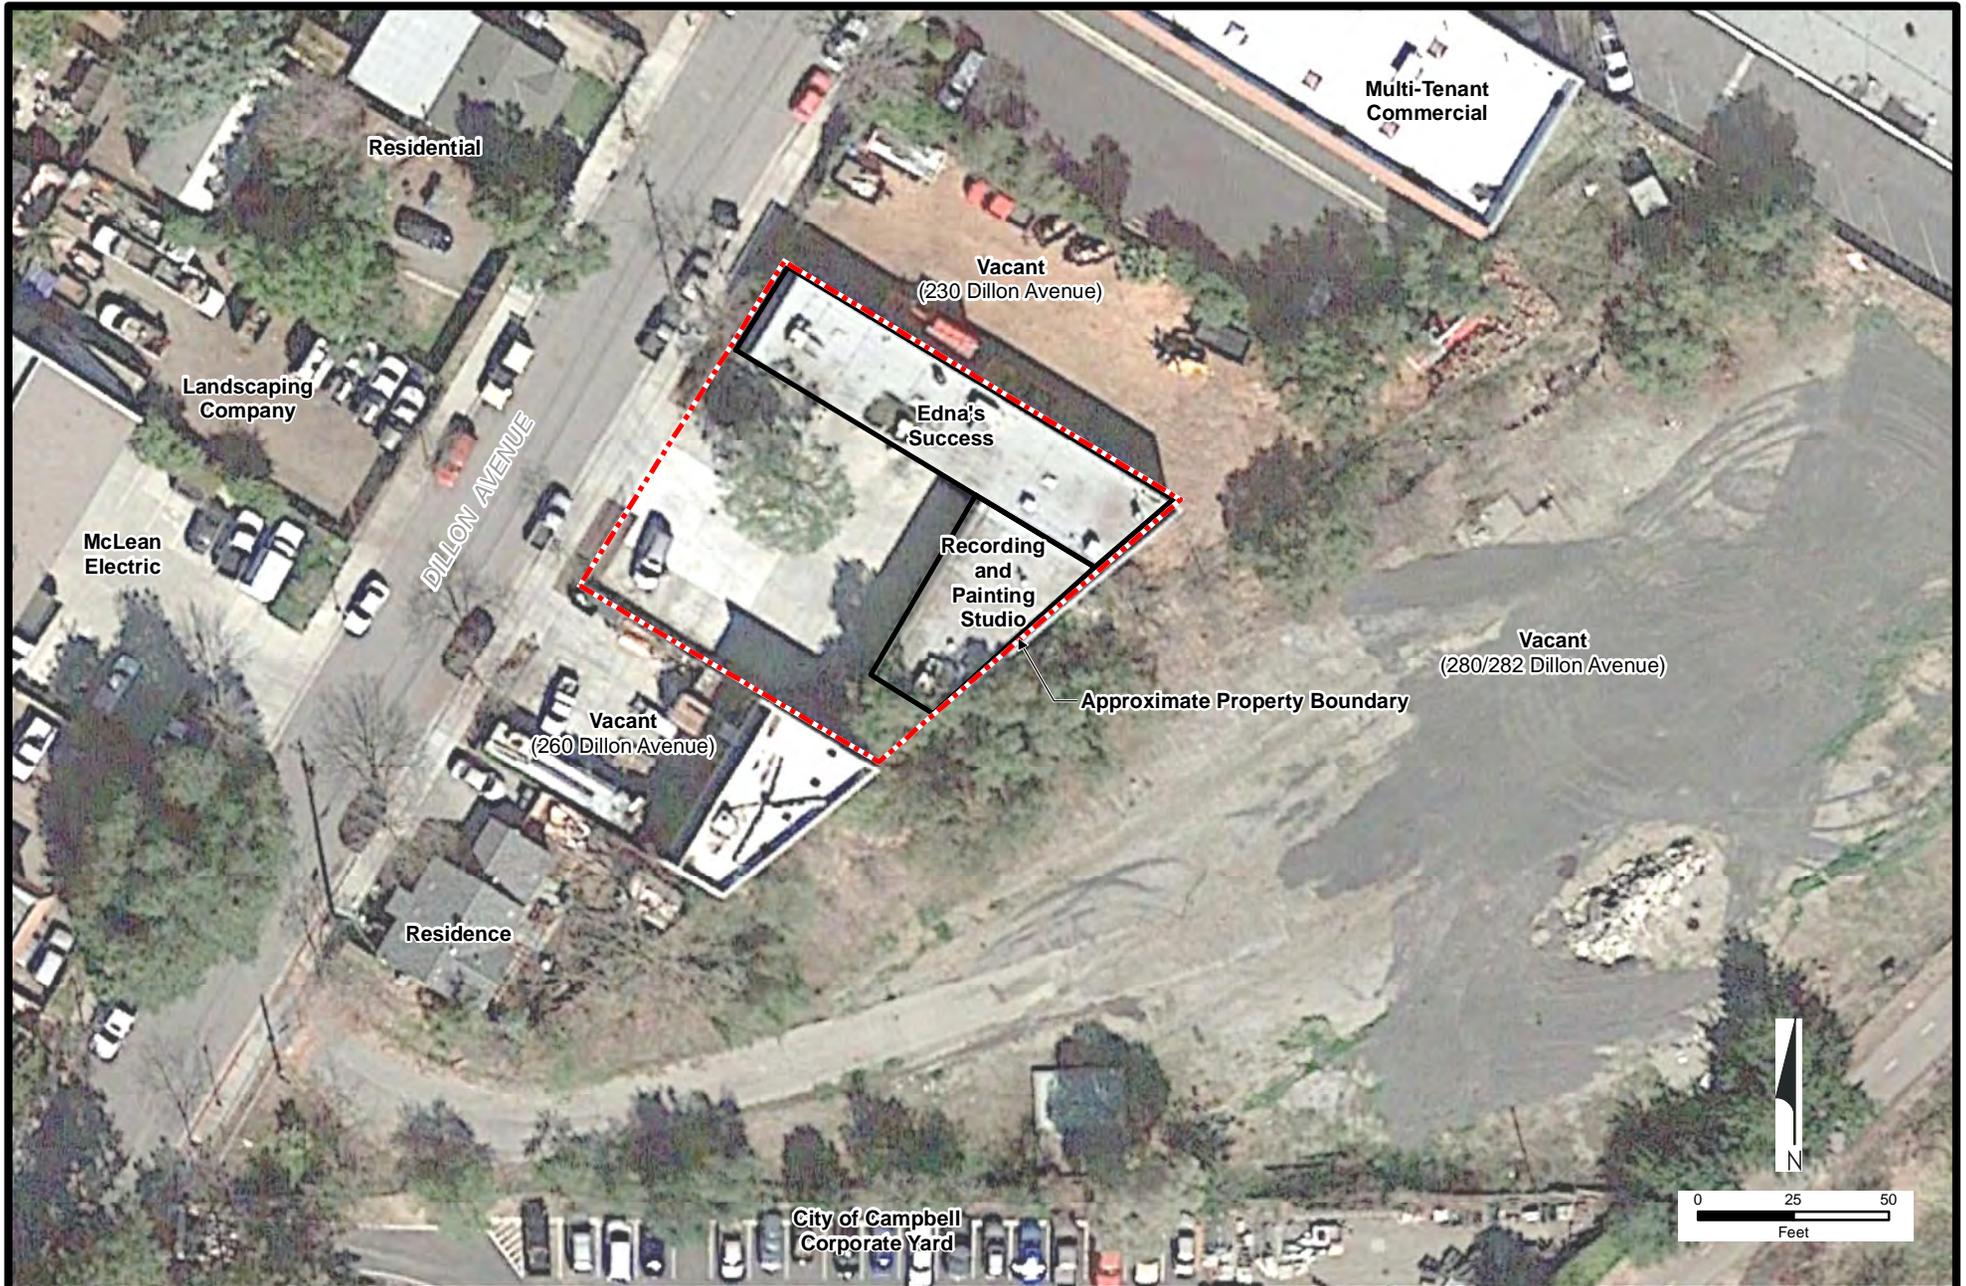
Figure

Site Layout
 240 and 250 Dillon Avenue
 Campbell, California

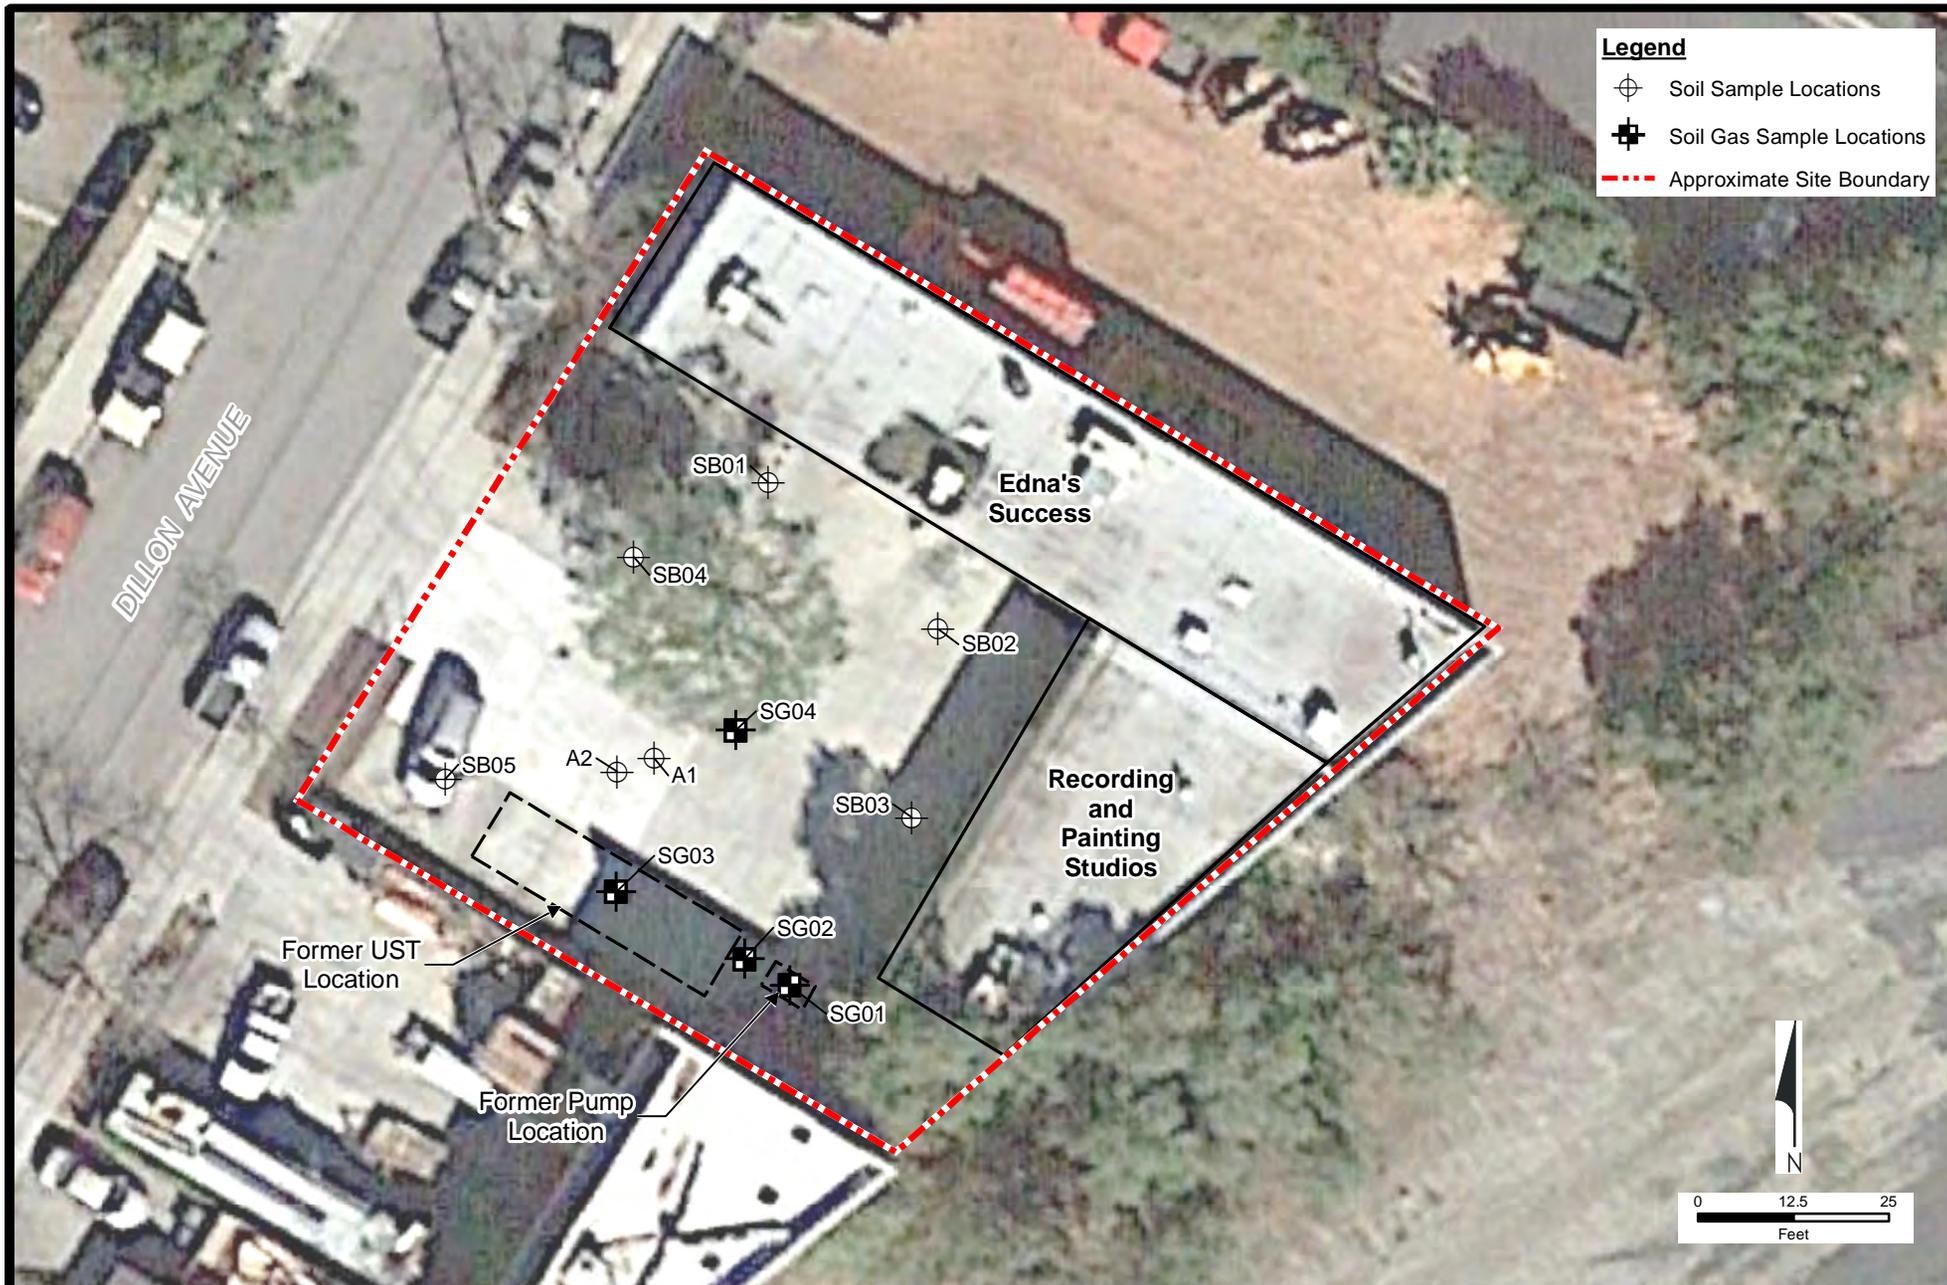
Figure

Sampling Location Map
 240 and 250 Dillon Avenue
 Campbell, California

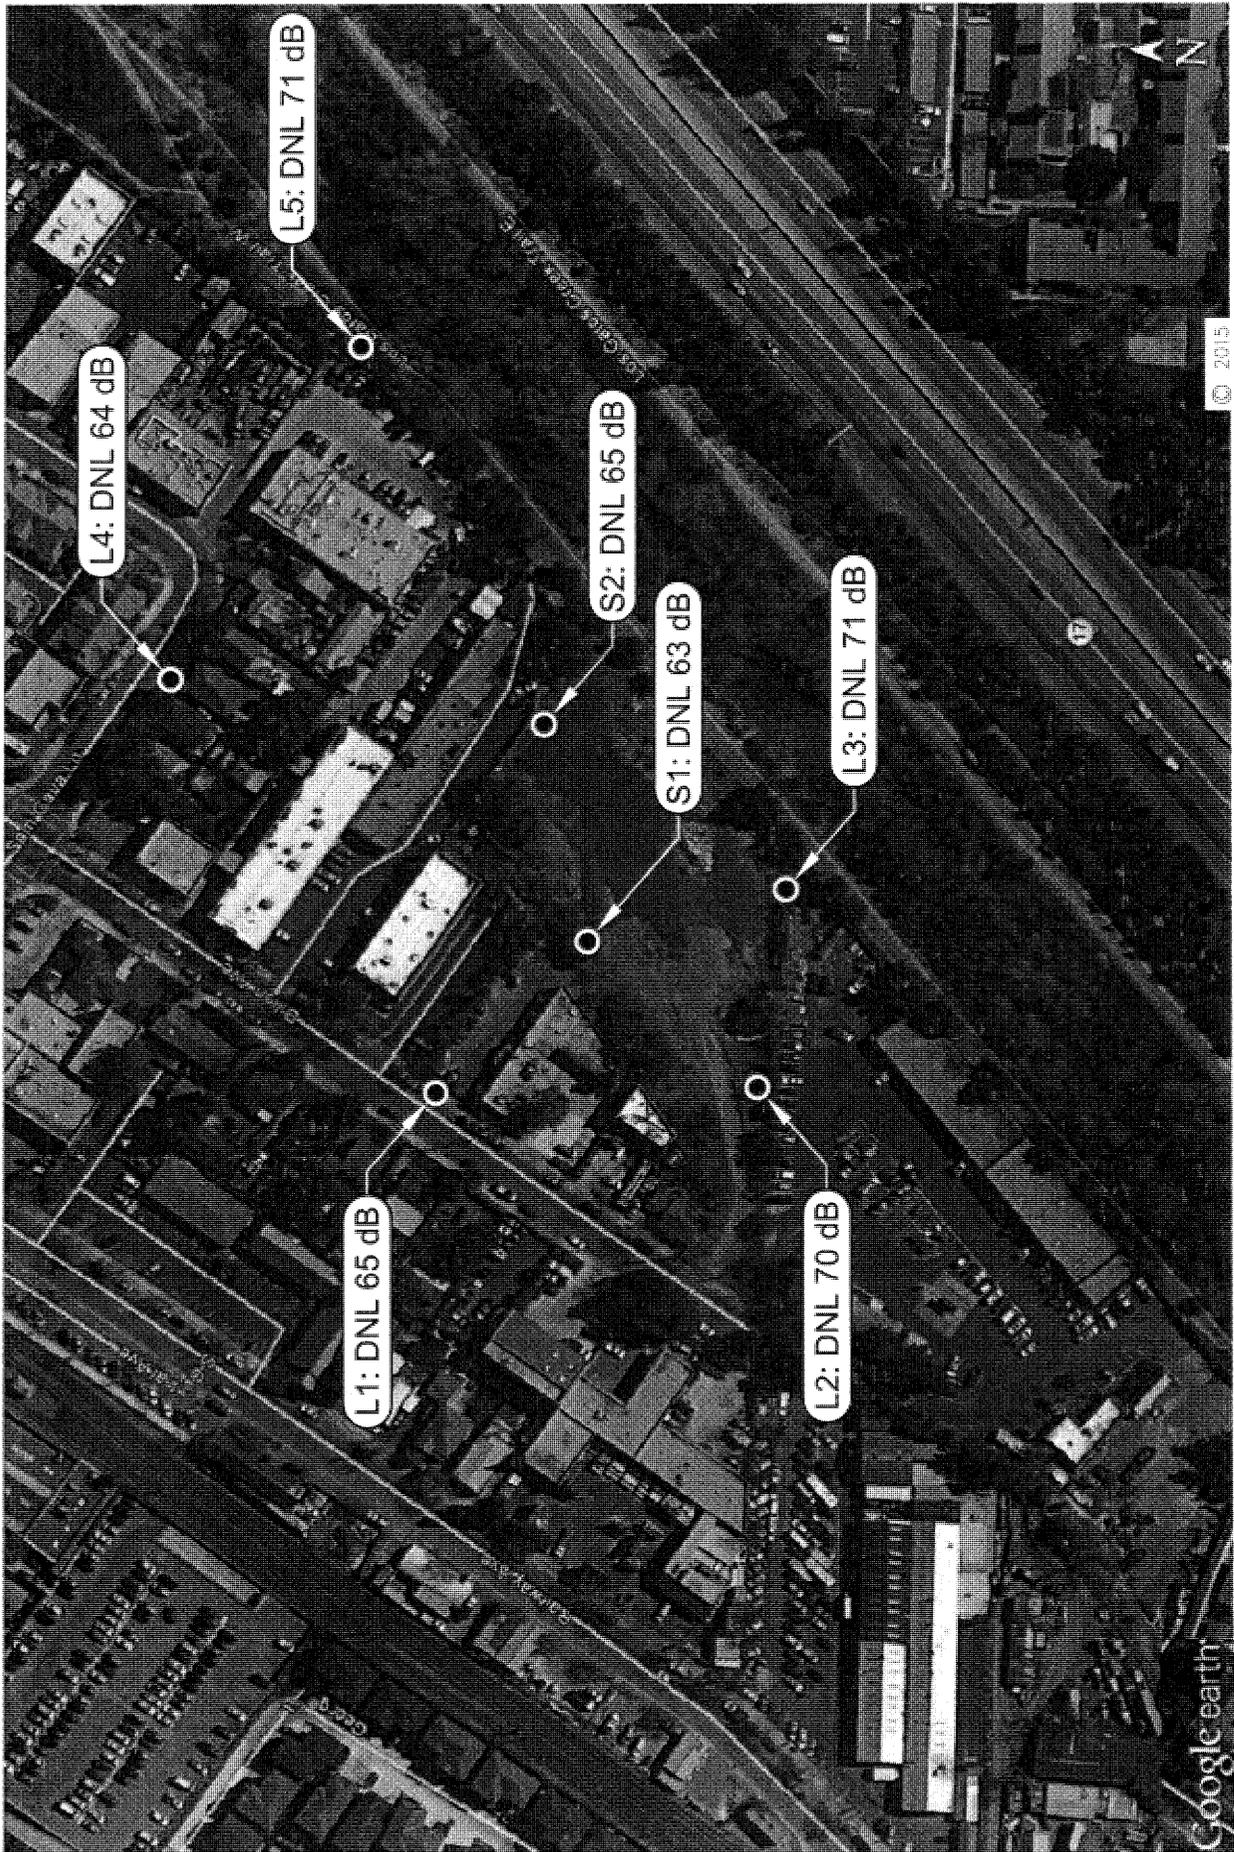
FIGURE 1

DILLON AVENUE – CAMPBELL, CA.
MEASUREMENT LOCATIONS AND MEASURED DNL

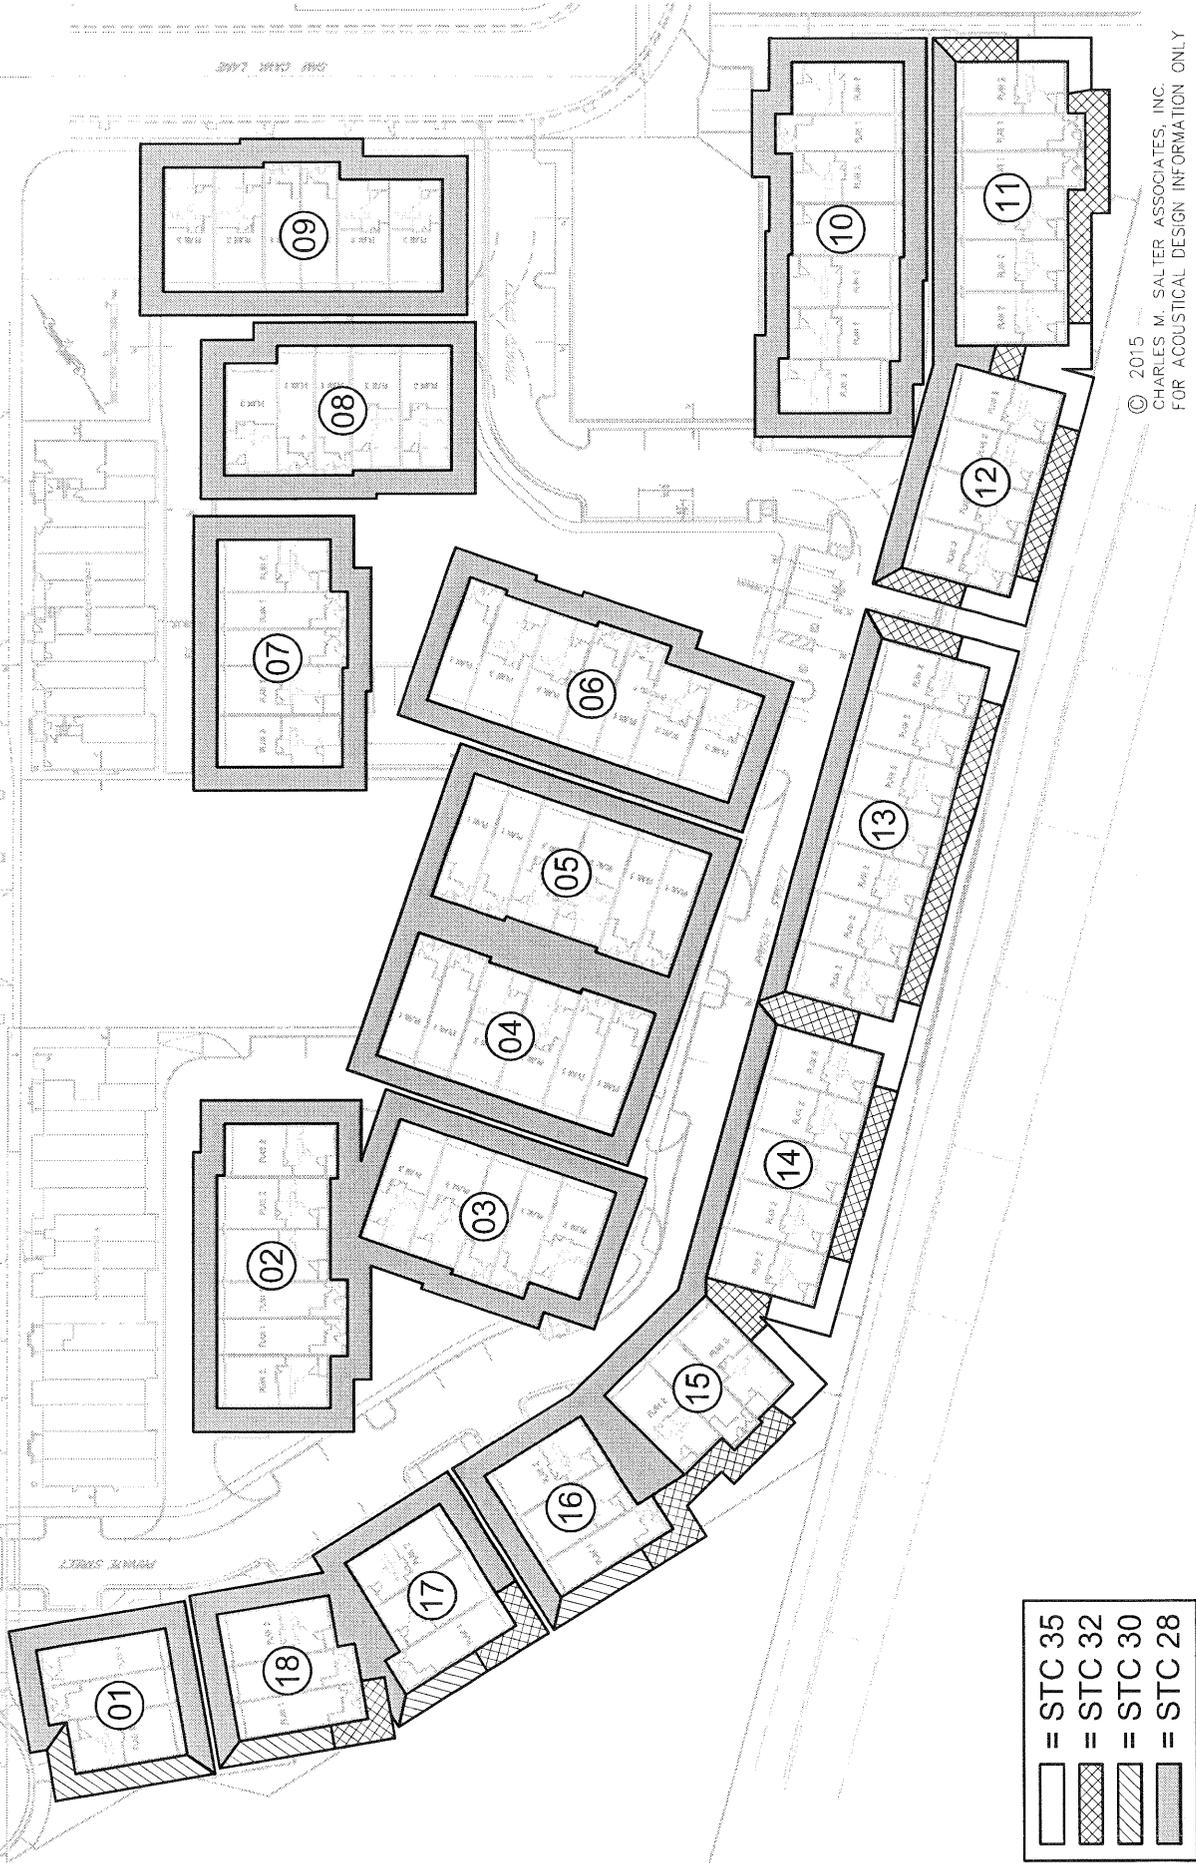
**DILLON AVENUE – CAMPBELL, CA.
 MINIMUM RECOMMENDED STC RATINGS FOR
 WINDOWS AND EXTERIOR DOORS**

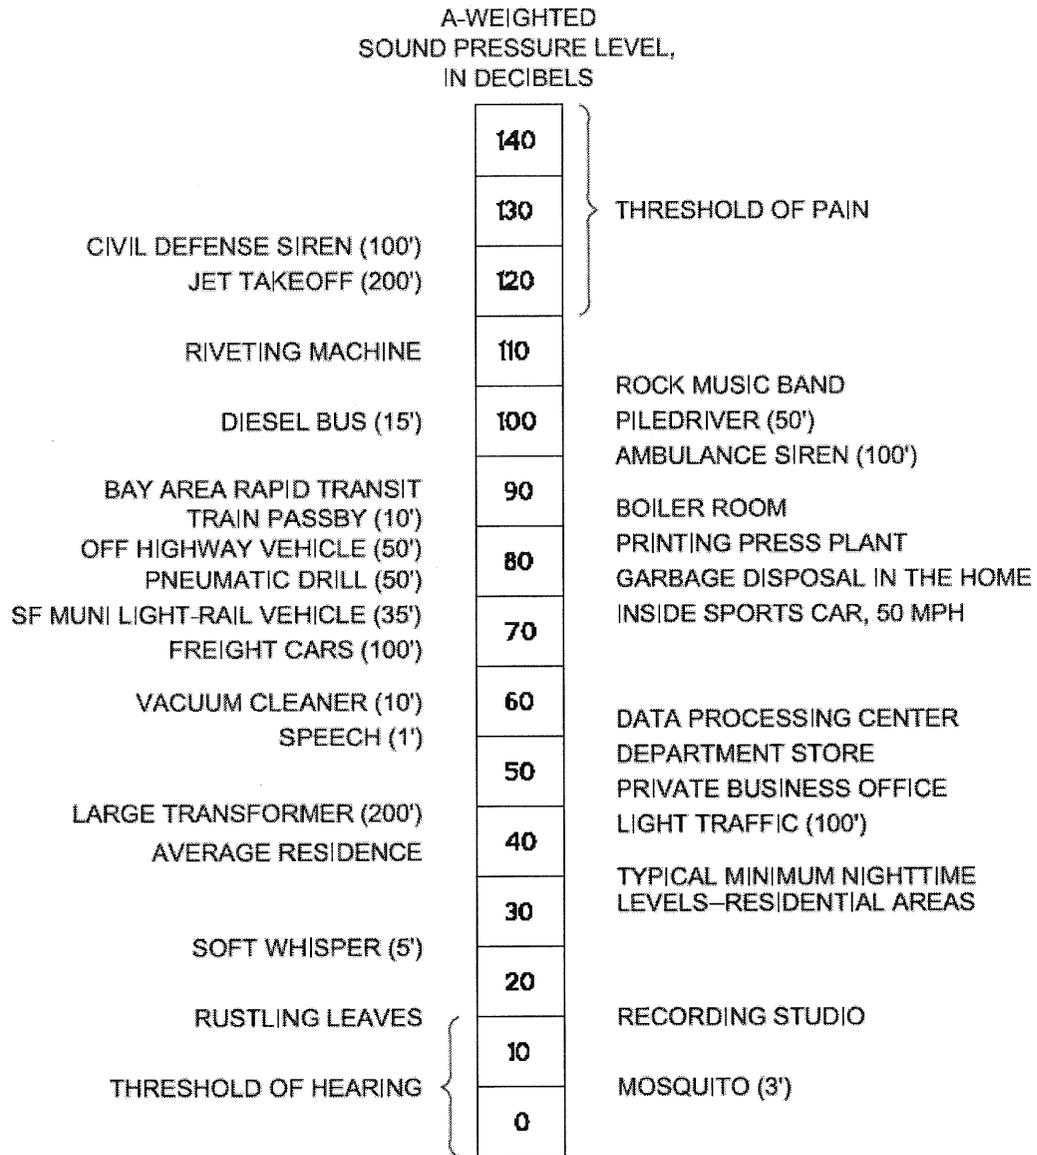
(100') = DISTANCE IN FEET
BETWEEN SOURCE
AND LISTENER
