NOTICE OF TREE REMOVAL PERMIT APPLICATION

Project Location: 175 Curtner Ave
Application Type: Tree Removal Permit
Planning File No.: PLN2018-89
Description: Removal of Three (3) Redwood Trees

Arborist Letter

Public Storage, 175 S. Curtner Ave Campbell CA 95008

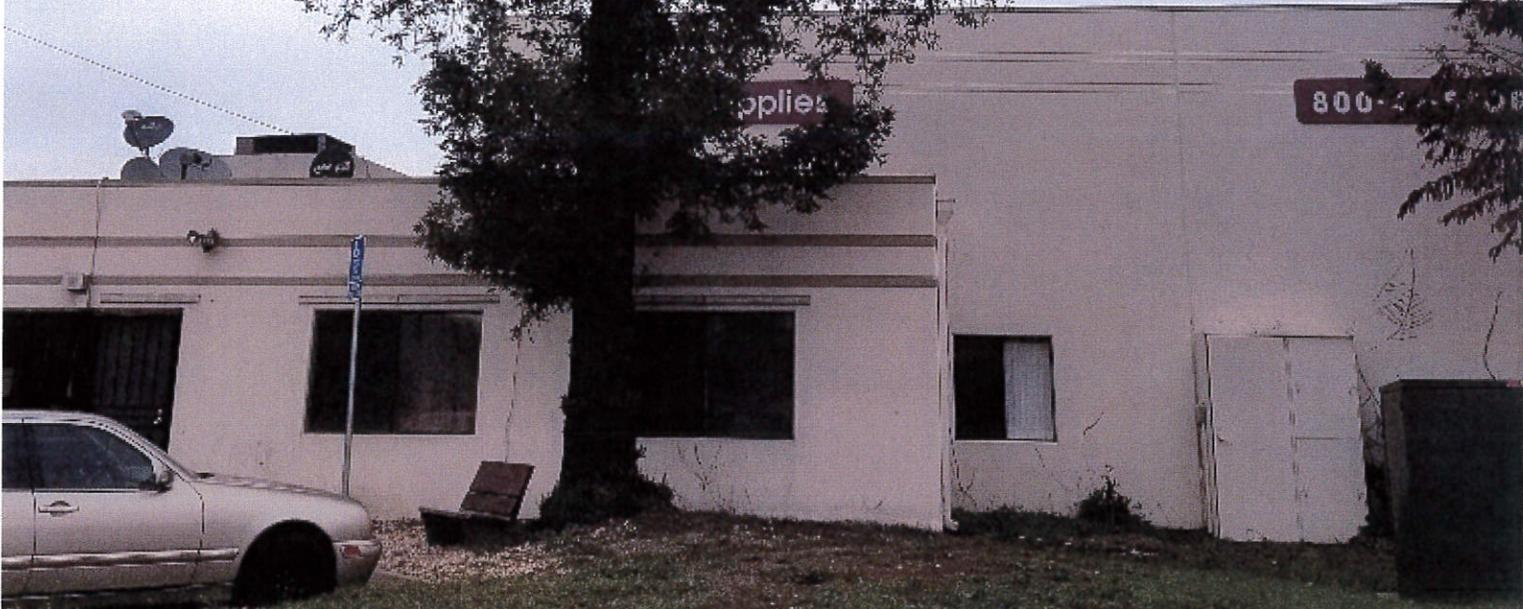
There are three Redwood trees that line the perimeter of the property along 175 S. Curtner Ave. These subject trees are approximately 25-30 feet tall and 16-20 inches wide. The three Redwood trees have a high potential to cause significant damage to the existing main structure due to their species growth characteristics and close proximity to the building. This cannot be alleviated through root pruning and or branch pruning techniques. Root pruning would need to occur within the drip line, which would most likely result in a reduced health and stability of the trees. There is also utility interference currently present with these trees. They have been topped by PG & E to clear the high voltage power lines. Topping will make a tree more hazardous in the long term. The severity of this type of pruning triggers a sort of survival mechanism. The tree activates latent buds, forcing the rapid growth of multiple shoots below each cut. This survival mechanism that causes a tree to produce multiple shoots below each topping cut greatly compromises the structure of the tree. These shoots develop from buds near the surface of the old branches. Unlike normal branches that develop in a socket of overlapping wood tissues, these new shoots are anchored only in the outermost layers of the parent branches. Unfortunately, the shoots are prone to breaking, especially during windy conditions. The irony is that while the goal was to reduce the tree's height to make it safer, it has been made more hazardous than before. Due to their location and the fast growing nature of these trees, PG & E will continue to top these trees.

← previously topped by PG & E

- in poor health
- close building proximity

Due to the potential for structural damage and current utility interference removal and replacement is recommended. A replacement plan with five 24 in box size trees with a species that appropriately matches the existing theme of the landscape is recommended. A smaller size tree at this site would be a more suitable and safer choice.
