NOTICE OF TREE REMOVAL PERMIT APPLICATION

Notice is hereby given that the Community Development Department of the City of Campbell has received an application for a Tree Removal Permit (PLN-2021-163) at 189 Redding Rd for the removal of one (1) Redwood tree measuring 36 inches in diameter located in the rear yard due to damage to the home. If approved, removal of the tree is subject to the replanting requirement of the Campbell Municipal Code.

Site Photographs

Re: Written Statement- Redwood- 189 Redding Road

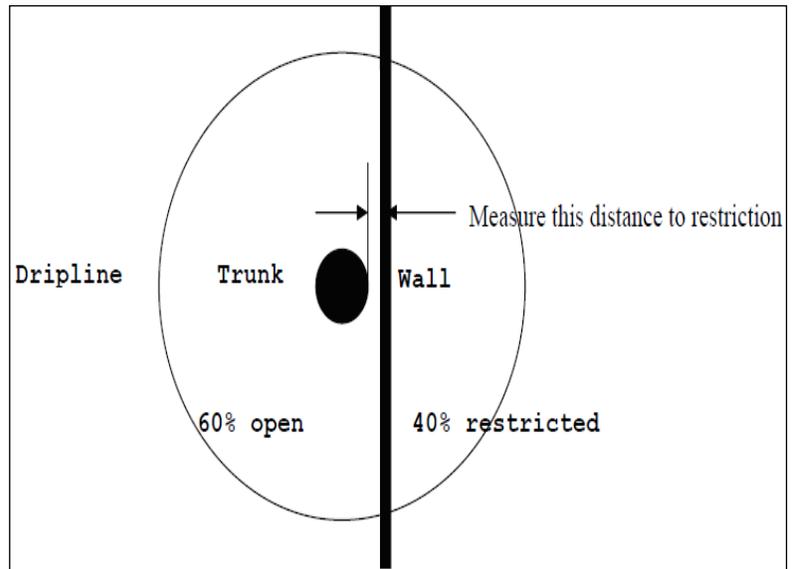
On the backyard side of the foundation, adjacent to the subject redwood tree, the inspection revealed one related stem wall foundation crack. The redwood pushing against the home's foundation is the cause of this stem wall distress. I am of the opinion that further foundation damage is inevitable as the tree continues to grow.

This cannot be controlled or remedied through reasonable modification of the tree's root system. Pruning tree roots can negatively impact two critical components of a tree: stability and health. Stability is my immediate concern, particularly with the redwood due to its immense size. Structural roots, which begin at the base of the tree, serve to stabilize the tree and prevent it from falling. The closer to the trunk roots are cut, the greater the probability the tree will become unstable and fall over. Arborist standards for root pruning are specified by the *American National Standards Institute (ANSI) A300 (Part 8) Root Management*. This standard emphasizes the potential for tree decline and destabilization when roots are damaged within six times the trunk diameter (DBH). With the redwood having an approximate 36" DBH, the standard discourages root pruning within 18 feet of the tree's trunk. The standard states that, "when roots are damaged within six times the trunk diameter (DBH), mitigation shall be recommended." Mitigation is not a viable option in this extreme circumstance. The structural integrity of the redwood has been irreversibly compromised.

An additional issue associated with this redwood's location is its inability to naturally extend its root system. The International Tree Failure Database (ITFD) was developed by the USDA Forest Service, in cooperation with the International Society of Arboriculture (ISA), to improve detection and understanding of tree hazards prior to failure. The ITFD Manual cites four categories of root failure which can lead to tree failure. One major predisposing factor for tree failure is a restriction in the rooting space available to a tree (see *Exhibit at right*). Root-impenetrable barriers associated with man-made structures that enter the ground, such as a house foundation, serve to limit a tree's root system. The redwood's close proximity to the home restricts a significant percentage of the available rooting space, or ability for the root system to naturally extend to provide support/stability for the tree. There are no mitigation efforts to address this deficiency.

Based upon the evaluation detailed above, the redwood is located too close to the existing home foundation and structure. The redwood will assuredly grow in size and, as a result, will cause increasing damage to the house foundation. In addition, the redwood's close proximity to the home has significantly restricted the tree's available rooting space and increased the likelihood of failure. There are no mitigation efforts to address this deficiency. The redwood represents a safety hazard to the people /residents, as well as the adjacent homes. I recommend removal of the redwood and replacement with a species better-suited for the location.
